## SUMMARY

1234 Main Street Waco TX 76708

Kris Cline  
TREC #26170  
Riverbend Inspections PLLC  
254-253-9051  
[kris@riverbendinspections.com](mailto:kris@riverbendinspections.com)

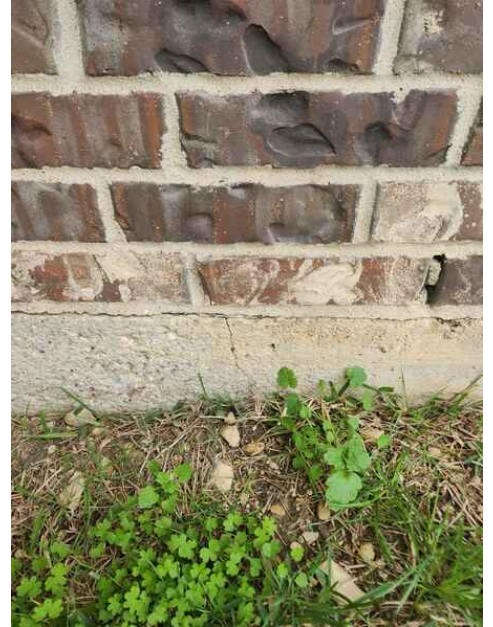
Back beside patio

#### FOUNDATION CRACKS - MINOR

Minor cracking was noted at the foundation. This is common as concrete ages and shrinkage surface cracks are normal. It not appear to be more than 1/4" wide or show signs of vertical displacement, or being wider at the top or bottom. Recommend monitoring for more serious shifting/displacement. If you have any further concerns about these cracks we recommend having a foundation specialist provide further evaluation and repair as recommended.

Recommendation  
Recommend monitoring.

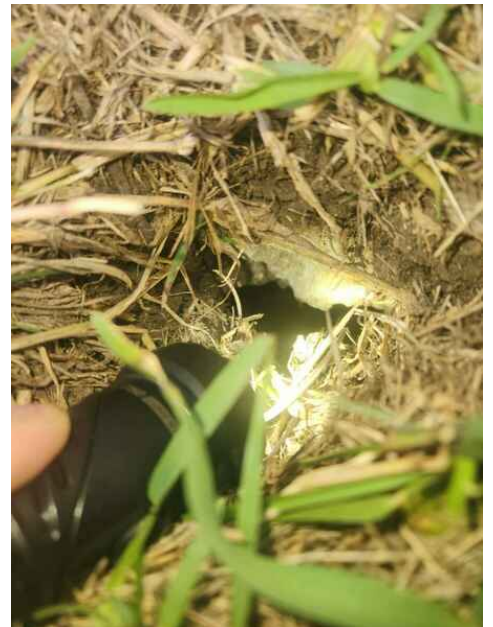
#### POTENTIAL ANIMAL BORROW

There was a hole in the ground near the front left corner downspout that may be a potential animal burrow but further evaluation would be needed by a pest control specialist to confirm. The hole is beside the foundation and goes below the footing. This hole may collect water and impact the integrity of the soil at the foundation which could lead to foundation issues if not corrected. Recommend a pest control specialist evaluate further and infill the hole after any pest concerns have been take care of.

Recommendation  
Contact a qualified professional.

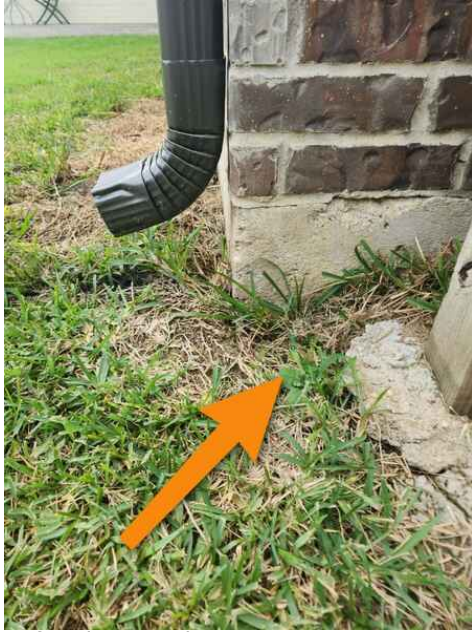
Left Side at Back

#### LOW SOIL LEVELS

Low soil levels were observed at multiple locations at the foundation perimeter beam. Fill dirt is needed against the foundation perimeter wall to help support the foundation properly and to prevent ponding and erosion. Correction of low soil levels at the foundation is recommended.

Contact a qualified landscaping contractor

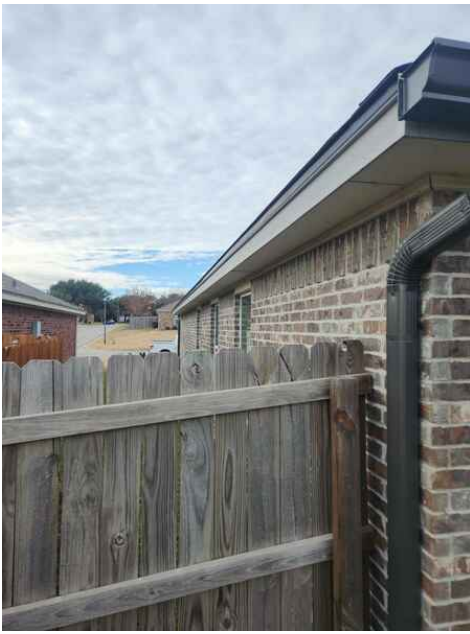
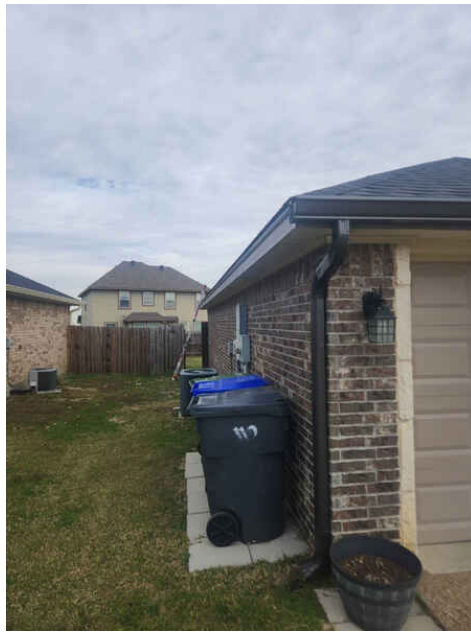
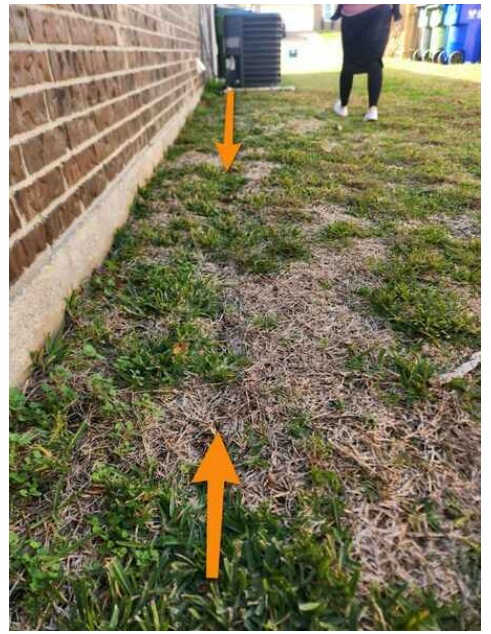
#### **NO GUTTERS AT RIGHT AND LEFT SIDES**

There was signs of erosion below the roofline where water is running off the roof where there is no guttering. In order for proper drainage away from foundation, and to prevent further erosion, installing guttering at the right and left sides is recommended.

Contact a qualified professional.

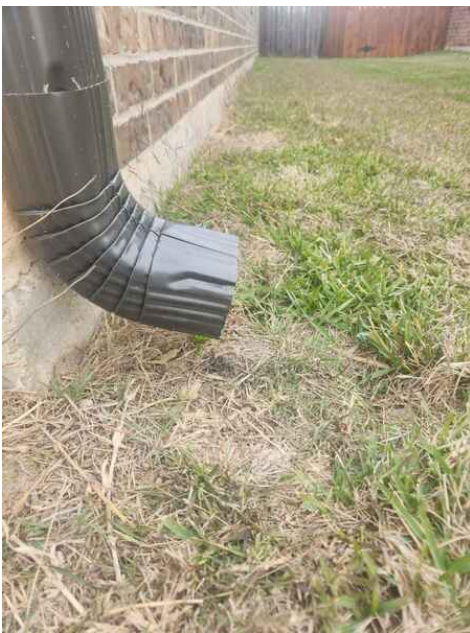
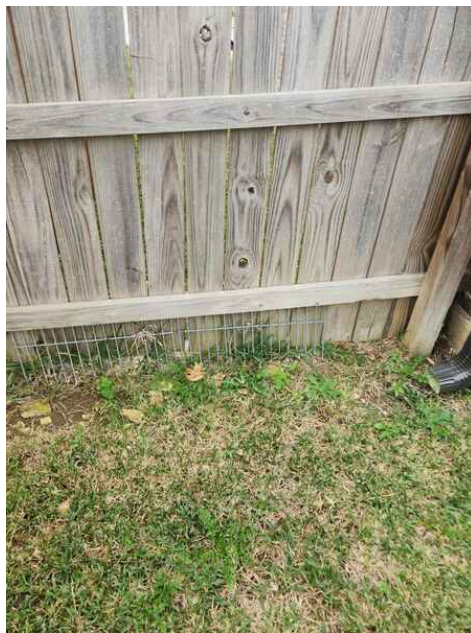
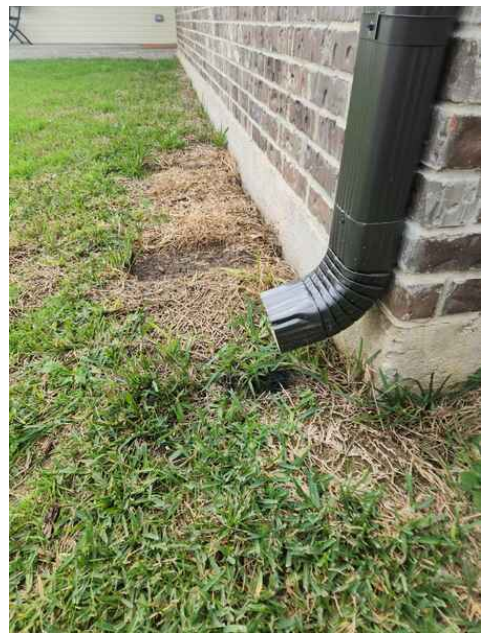
**TERMINATION TOO CLOSE AND EROSION AT DOWNSPOUTS**

Erosion was observed at multiple downspouts. An extension or splash block is recommended to divert water at least 5 feet away from the foundation to prevent erosion and expanding of soil that may have an adverse impact on foundation performance.

Recommendation  
Contact a handyman or DIY project

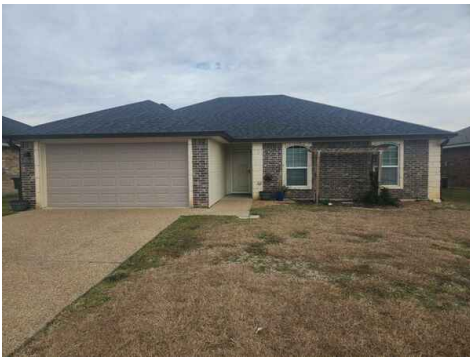
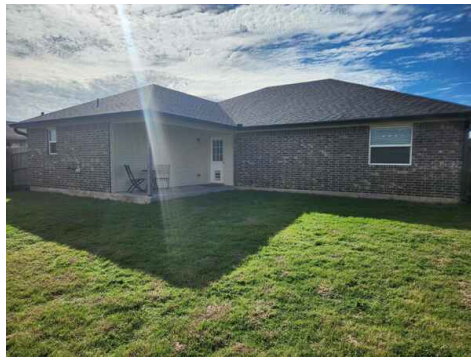
**INSUFFICIENT DOWNSPOUTS**

There should be a downspout for roughly every 40 feet of gutter. Recommend additional downspouts be installed between the two at both the front and back to properly drain water away. This may be a potential factor in the low spot at the back patio, and the settlement at the front entry sidewalk

Recommendation  
Contact a qualified professional.

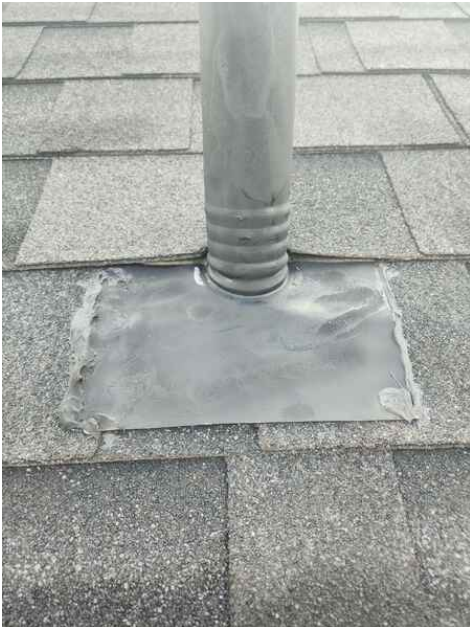
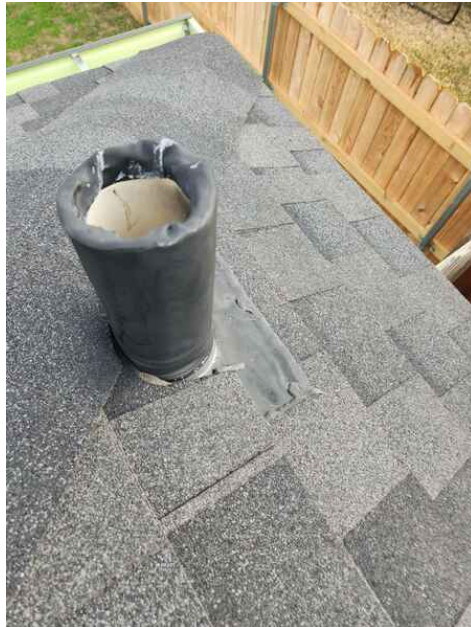
#### **ROOFING SEALANT AT VENT BOOT**

There was roofing sealant used to seal edges of vent boots at multiple locations. May be a potential repair to a leaking flashing. Recommend inquiring of the current owner about any leaks or repairs that may have been made. Sealants at flashings are not a permanent solution. Repair and replacement by a qualified roofing contractor is recommended if this was an attempted repair.

Contact a qualified roofing professional.

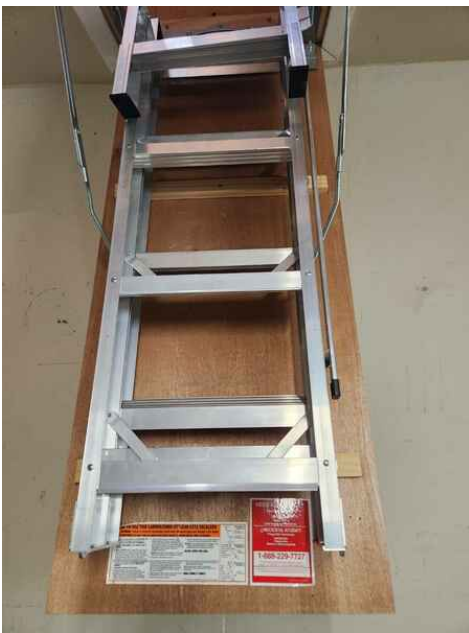
#### **ATTIC PULLDOWN STAIR DOOR NOT FIRE RATED**

The attic stair door was not fire rated and breaks the continuity of fire separation between the home and attached garage which is required by current standards.

Contact a qualified carpenter.

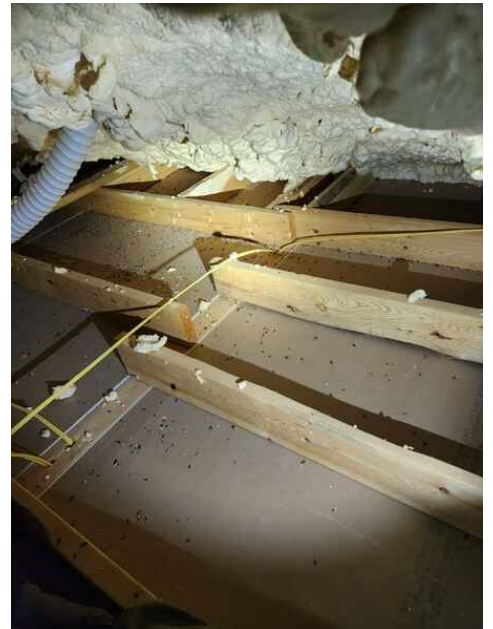
### EVIDENCE OF RODENTS

There was a significant amount of rodent droppings in the attic. Recommend a pest control specialist provide further evaluation and make necessary corrections to prevent further damage (see note regarding damage in walls section).

Recommendation  
Contact a qualified professional.

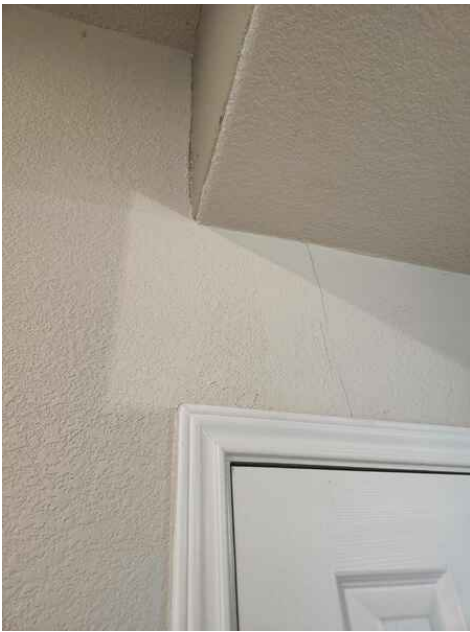
Pantry Door

### CRACKS - SEAM (COSMETIC):

Seems cracks are common over time and due to minor settlement and are cosmetic in nature. There were seem cracks observed at the following locations:

Recommendation  
Contact a qualified professional.

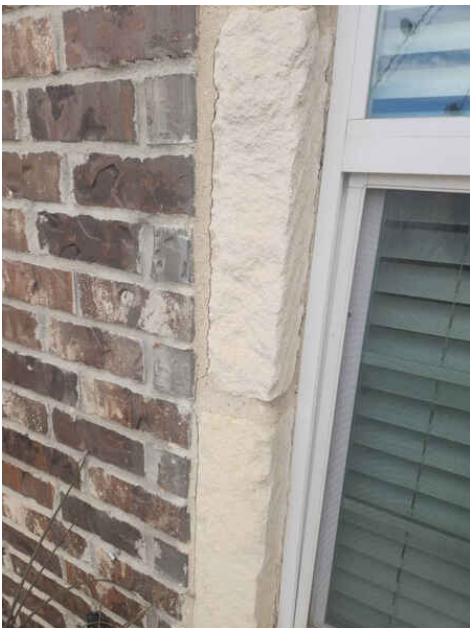
Front Window by Front Door

**CRACKING- MORTAR MINOR**

There were multiple locations observed that had minor mortar crack. The cracks appear to shrinkage cracks and are mostly cosmetic in nature. Mortar Cracks can allow moisture intrusion and cause further deterioration of masonry cladding.

Recommendation  
Contact a qualified professional.

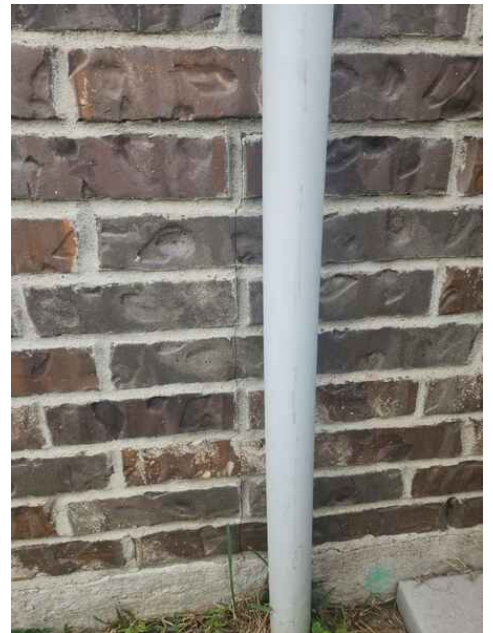
#### **CRACK IN MASONRY**

A crack was observed at the exterior cladding that goes through both the mortar and masonry. Recommend repair of crack and monitoring for additional movement and/or expansion.

Recommendation  
Recommend monitoring.

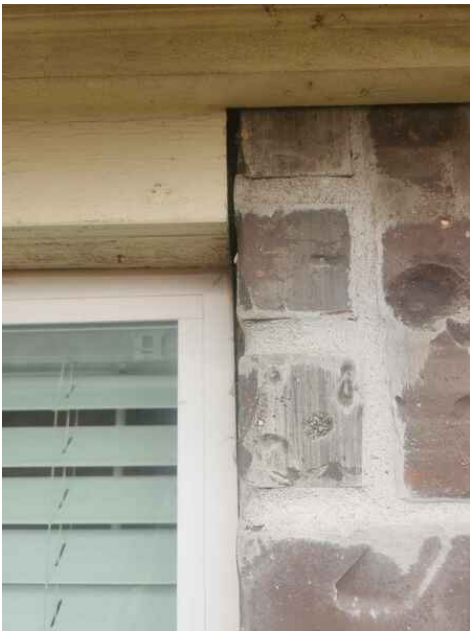
Multiple Windows

#### **SEALANT IMPROVEMENTS AT EXTERIOR TRIM**

Sealant was observed to be missing, deteriorated, or inadequate and in need of improvement at exterior trim at one or more locations. Recommend improvement be made to prevent moisture, pest, and insect intrusion.

Recommendation  
Contact a handyman or DIY project

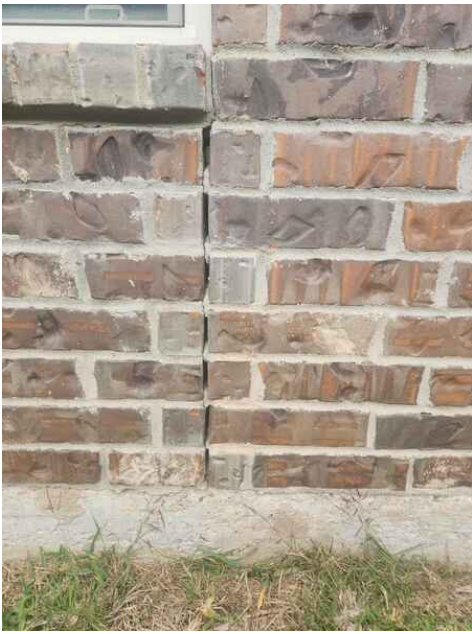
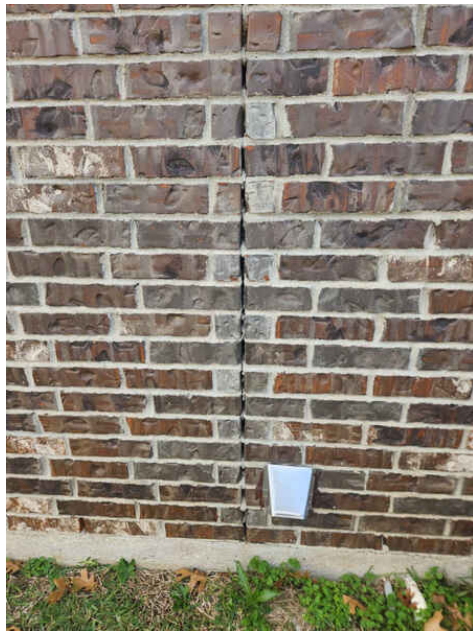
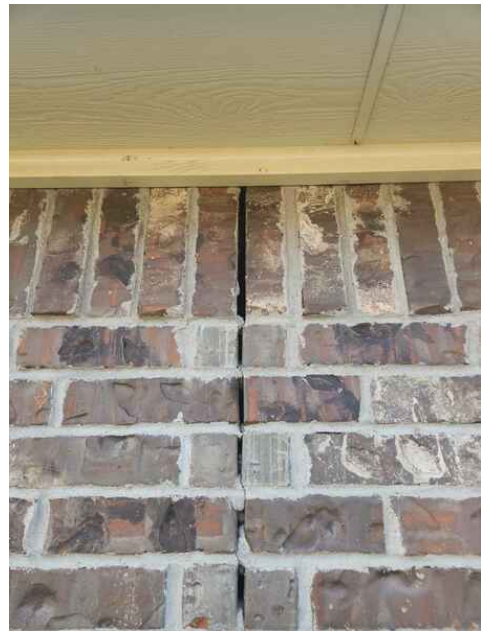
#### **NO SEALANT AT CONTROLS JOINTS**

There was no sealant observed in the brick control joints. It is recommended that sealant be properly installed to seal this gap to prevent water, pest, and insect intrusion.

Contact a handyman or DIY project

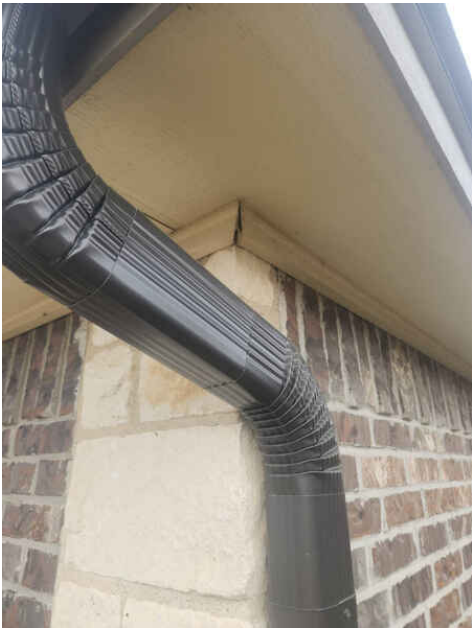
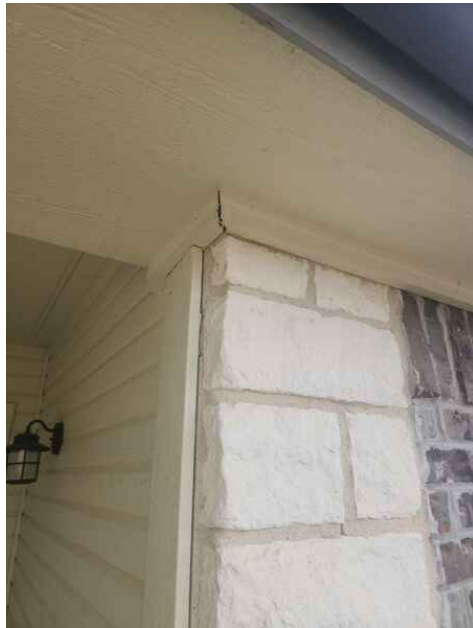
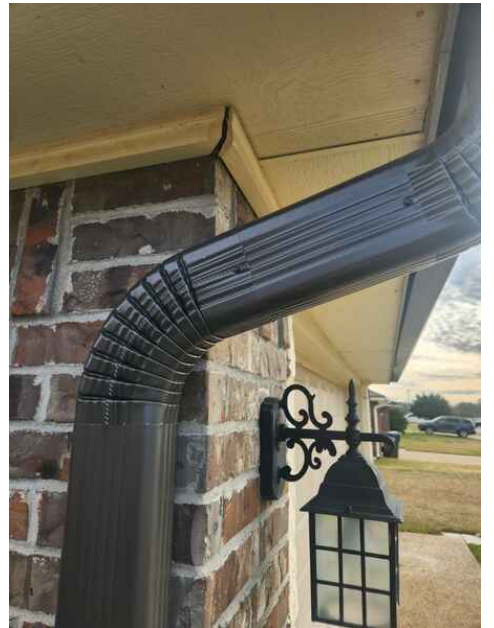
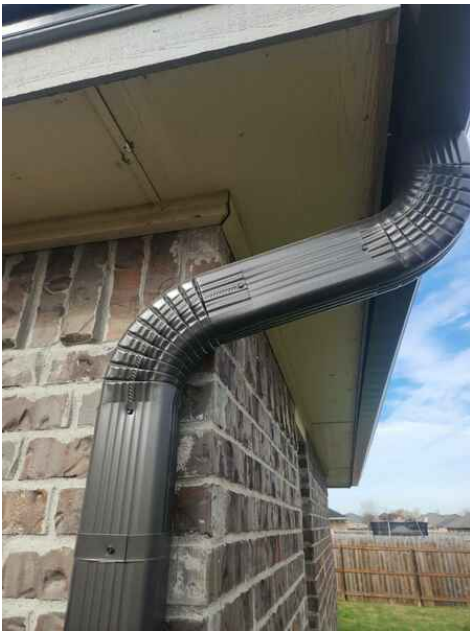
#### **FRIEZE BOARD GAP**

The frieze board trim has separated at several corners. It is recommended that sealant be properly installed to seal this gap to prevent water, pest, and insect intrusion.

Contact a handyman or DIY project

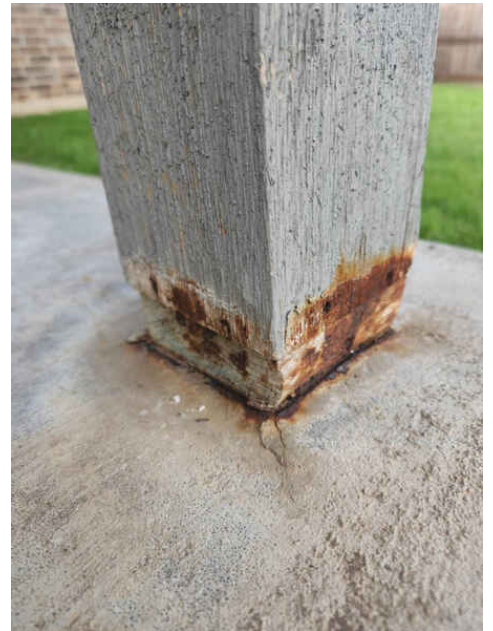
### WOOD COLUMN DETERIORATION

There is some signs of deterioration at the bottom of the wood column at the back patio. Recommend a qualified contractor or handyman install a metal bracket or other form of separation between the concrete and wood column.

Recommendation  
Contact a qualified professional.

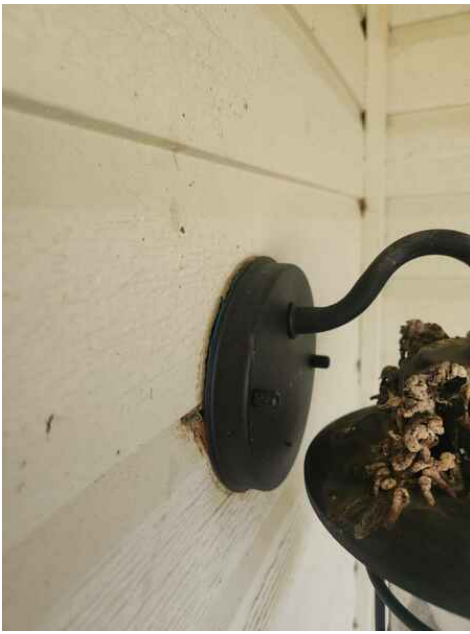
### SEALANT AT BACK PATIO FIXTURE

It is recommended that sealant be properly installed to seal this gap to prevent water, pest, and insect intrusion.

Recommendation  
Contact a qualified professional.

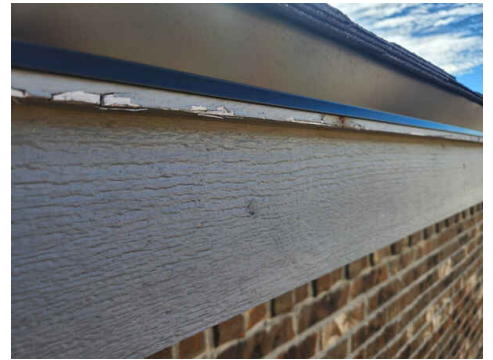
Left side eve

**PAINT IMPROVEMENTS**

Paint is chipping and or peeling at eve below drip edge at left side of house. Recommend painting improvement be made as needed to protect the trim and prevent moisture damage.

Recommendation  
Contact a qualified professional.

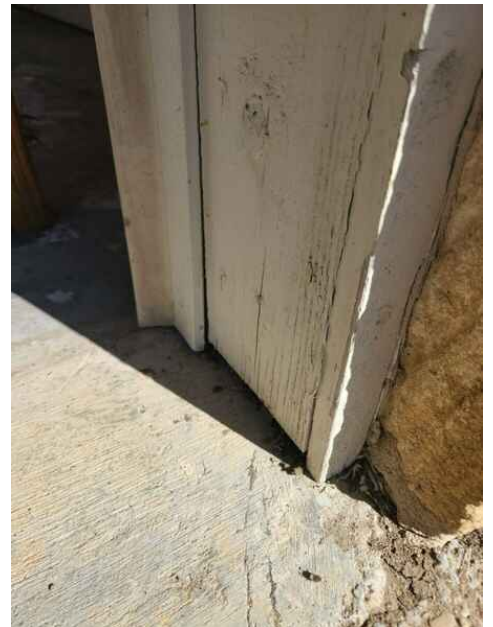
**MOISTURE DAMAGE AT GARAGE DOOR TRIM**

Slight moisture damage at Garage door surround. This is very common, and mostly cosmetic, as the trim is usually installed to close to grade. Recommend qualified professional cut back trim for 1 to 2 inches of clearance to avoid any further damage.

Recommendation  
Contact a qualified professional.

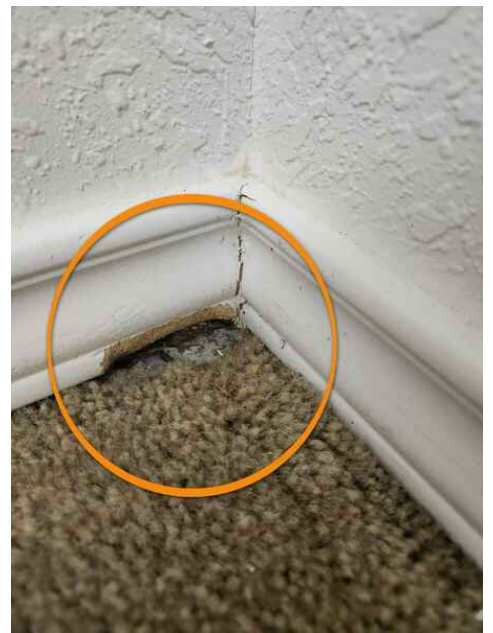
Master closet

**POTENTIAL RODENT DAMAGE**

What appeared to be rodent damage and access point was observed in the corner of the master bedroom walk-in closet. Recommend a pest control specialist evaluate further and make corrections as require.

Recommendation  
Contact a qualified professional.

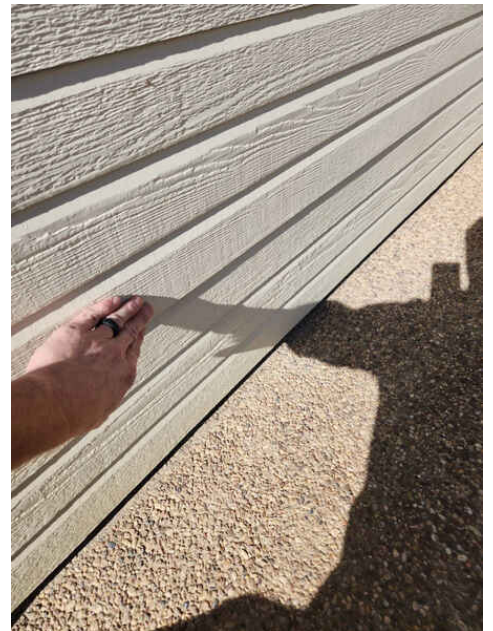
Right of garage at entry

### LOOSE SIDING

There was a section of siding that was loose and bowed out from wall slightly at the front entry. Recommend a qualified carpenter make the necessary repairs.

Recommendation  
Contact a qualified professional.

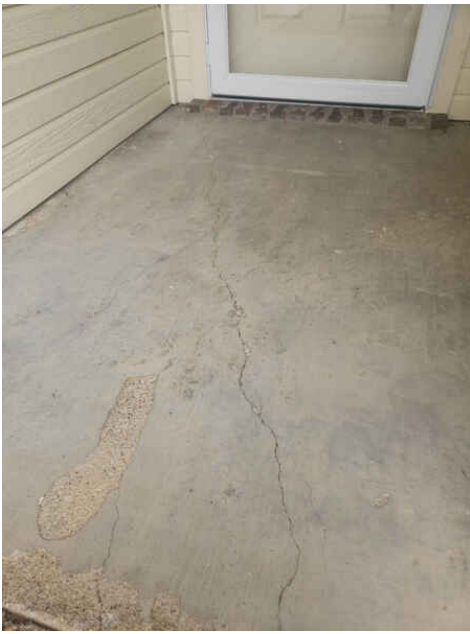
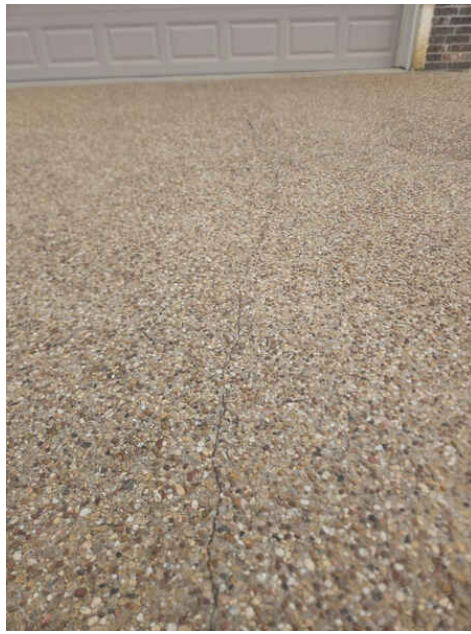
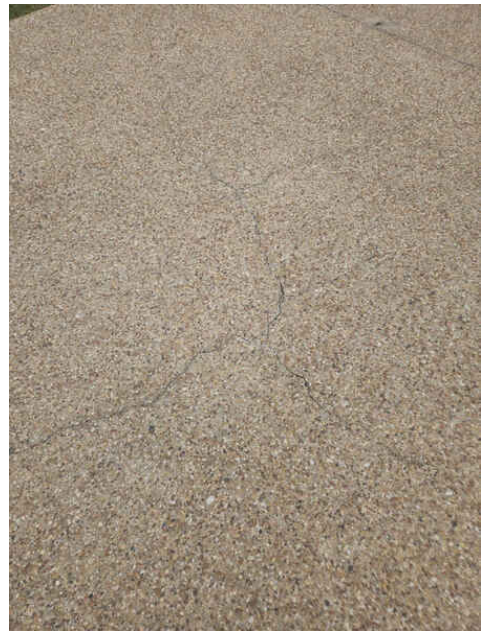
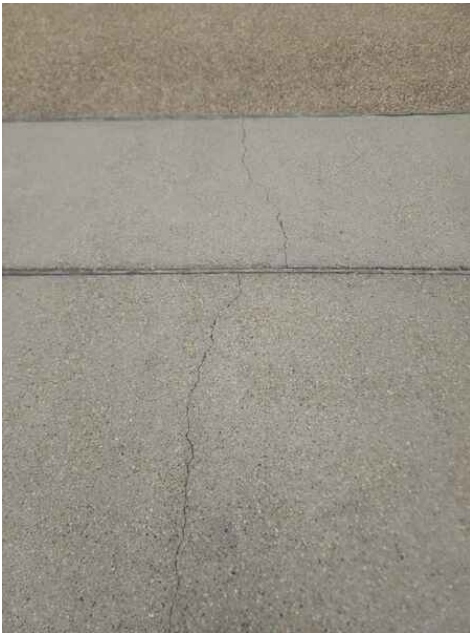
### CRACKS IN CONCRETE (MODERATE)

There were cracks in the concrete that are larger than shrinkage crack. This may be due to settlement. Monitor cracks for expansion and movement. If these cracks are cause for concern we recommend further evaluation by a qualified professional.

Recommendation  
Recommend monitoring.

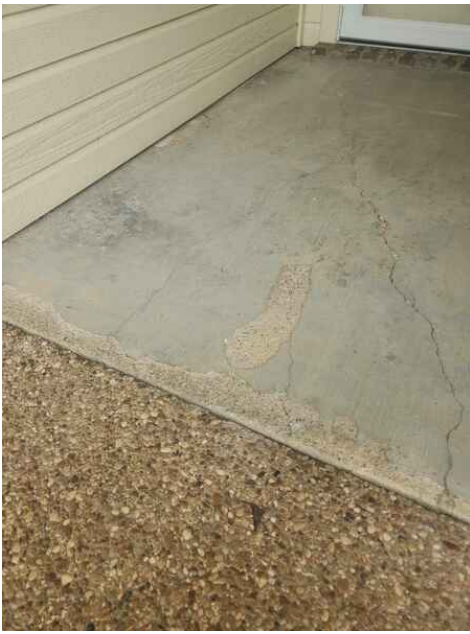
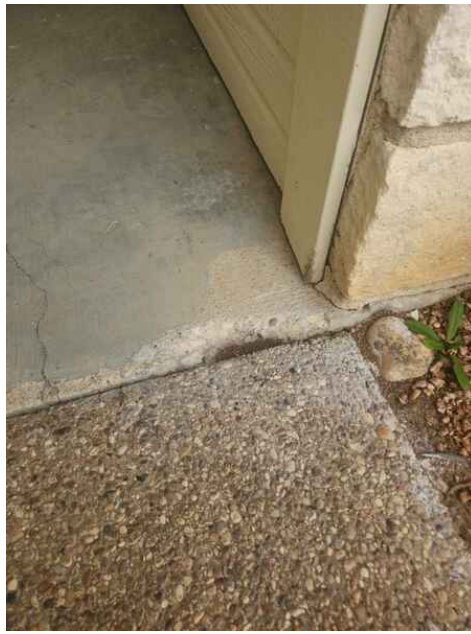
### **DAMAGE TO CONCRETE AT PATION**

The surface is spalling off and there is a damaged section of the concrete at the front patio concrete. Recommend monitoring to see if further spalling continues. If these items are a cause for concern, repair by a qualified contractor is recommended.

Contact a qualified concrete contractor.

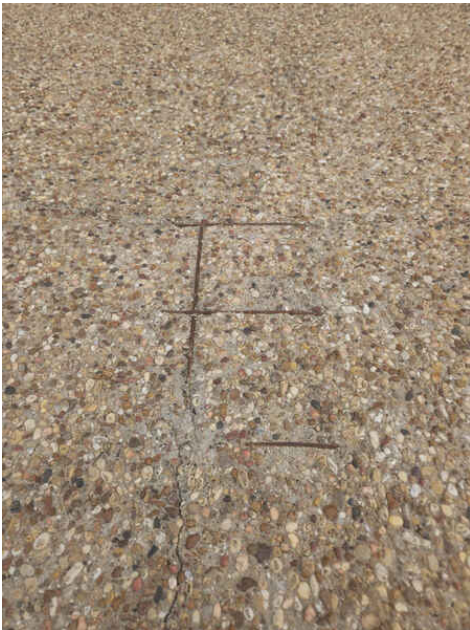
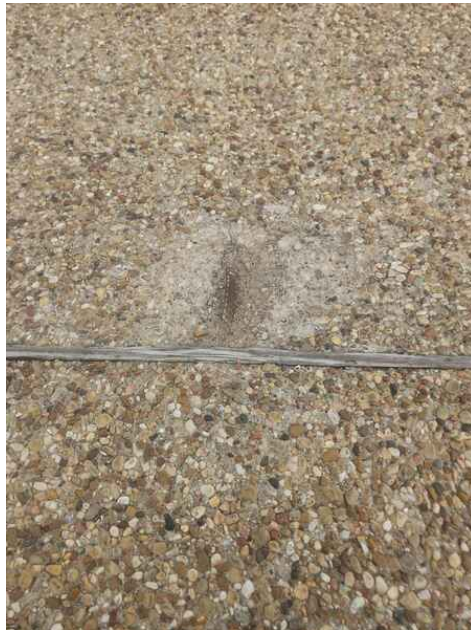
2.6.3 F. Ceilings and Floors  
**EXPOSED REINFORCING**

Recommend repair by a qualified contractor to prevent further deterioration.

Contact a qualified concrete contractor.

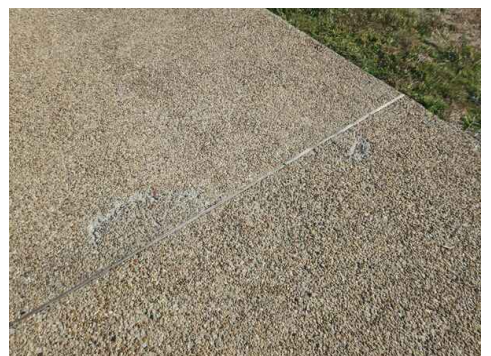
2.6.4 F. Ceilings and Floors  
**DRIVEWAY DAMAGE**

Mild damage was observed at the driveway. Recommend repairing or sealing as needed to prevent further damage or deterioration.

Contact a qualified concrete contractor.

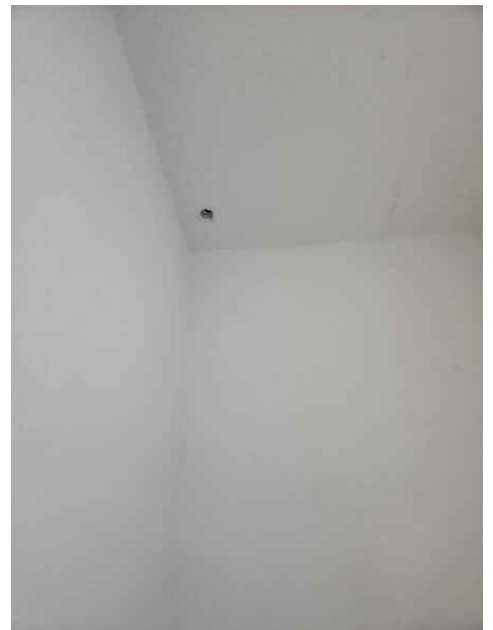
Closet of first bedroom on right

**ABANDONED HOLE**

There was an abandoned hole in the closet ceiling. Recommend repairing hold as required.

Contact a handyman or DIY project

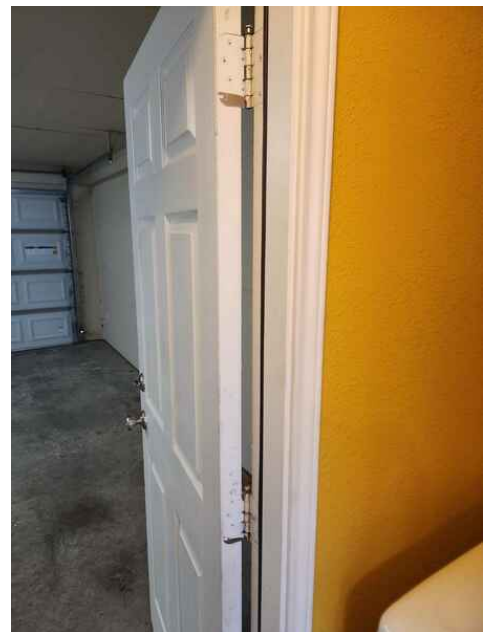
**GARAGE PASSAGE DOOR NOT SELF CLOSING**

The passage door of an attached garage should have self closing hinges. The ensures the door will always close and not compromise the fire barrier between the garage and the inhabitable area of the home. Recommend installation of self closing door hinges.

Contact a qualified professional.

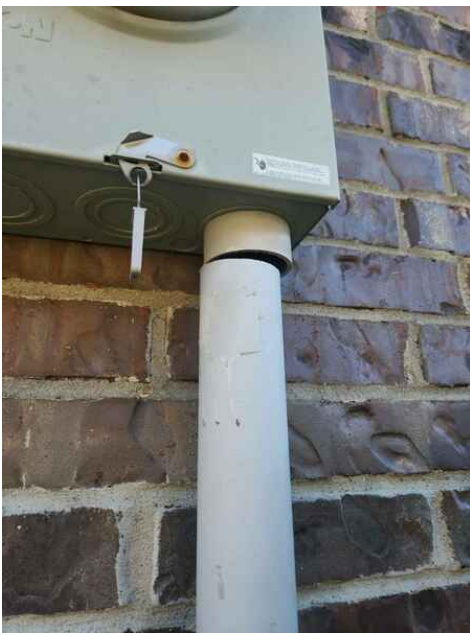
**SERVICE CONDUIT**

The service conduit was not properly connected together at the panel box. This separation can allow moisture, insects, and rodents into the conduit and panel box. Recommend this be corrected by a qualified electrician.

Contact a qualified electrical contractor.

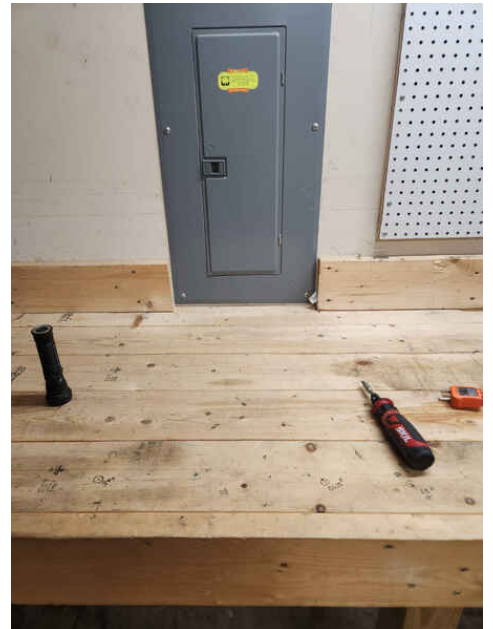
#### **IMPROPER CLEARANCE**

There should be 3 feet in front of the panel and 30 inches side to side for clearance for anyone to safely work at the panel if needed. Recommend making corrections as needed for the proper clearance.

Recommendation  
Contact a qualified professional.

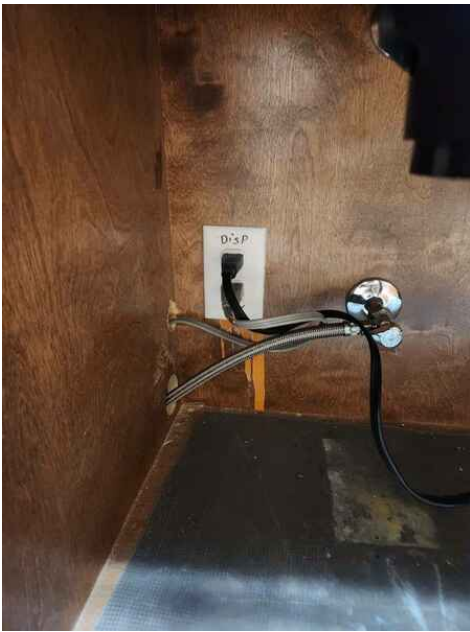
Dishwasher Plug in Under Sink

#### **ABSENCE OF GROUND FAULT CIRCUIT INTERRUPTER (GFCI) PROTECTION**

GFCI protection (Breaker or receptacle) are required in the following locations per current building standards; bathroom receptacles, garage and accessory building receptacles, outdoor receptacles, crawl space receptacles and lighting outlets, basement receptacles, receptacles that serve kitchen countertops, receptacles that are located within six feet of the outside edge of a sink, shower, or bathtub, laundry area receptacles, indoor damp and wet location receptacles, kitchen dishwasher receptacle, and electrically heated floors. Recommend a qualified electrician make the necessary repairs to provide GFCI protection for locations noted.

Recommendation  
Contact a qualified electrical contractor.

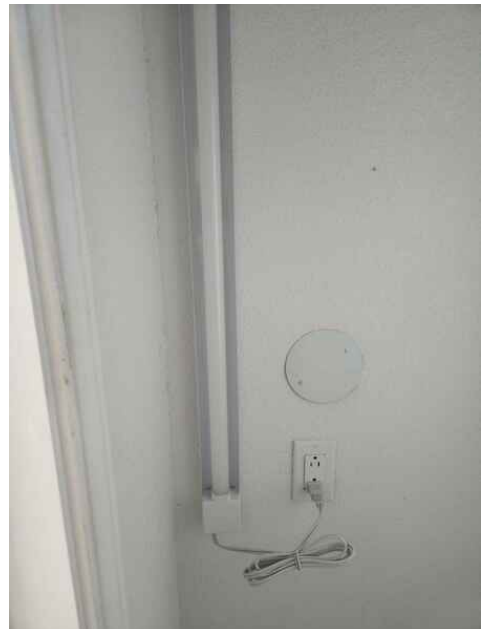
Front Bedroom Closet

**EXTENSION CORD WIRING**

Extension cord(s) used as permanent electrical conductors was observed. Electrical standards do not allow extension cords to be used for permanent wiring and is considered a safety hazard. Recommend replacement of extension cord wiring with the appropriate electrical conductors by a qualified electrician.

Contact a qualified electrical contractor.

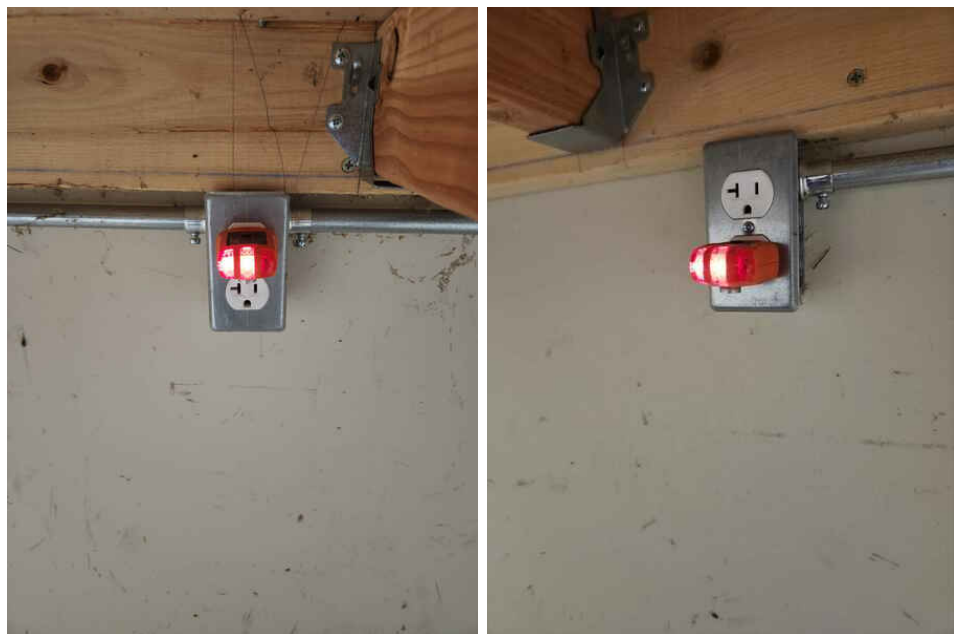
**REVERSE POLARITY**

One or more receptacles showed to be wired incorrectly when tested with a receptacle Tester. Reverse Polarity is when the the hot and neutral wires are reversed and connected to the wrong connections on the outlet. Receptacle that have revers polarity increase the risk for shock or fire and are a safety hazard. Recommend a qualified electrician repair any receptacles that are wired incorrectly.

Recommendation  
Contact a qualified electrical contractor.

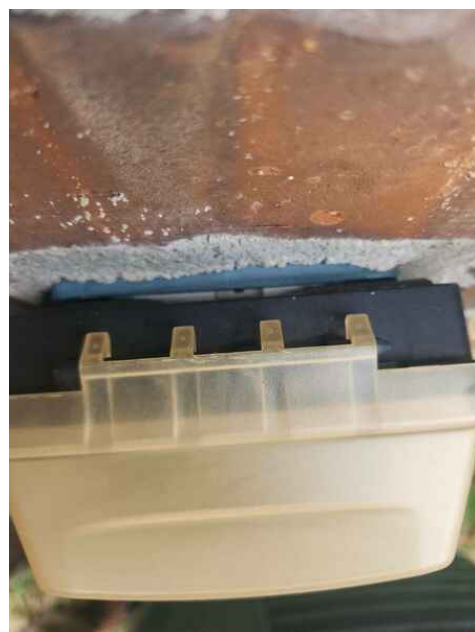
Left side exterior

### EXPOSED ELECTRICAL BOX

Electrical outlet and receptacle were exposed at left side exterior receptacle. This could lead to moisture entering the outlet and poses a safety risk. Recommend the necessary repairs be made by a qualified professional to protect electrical outlet and receptacle from water exposure.

Recommendation  
Contact a qualified professional.

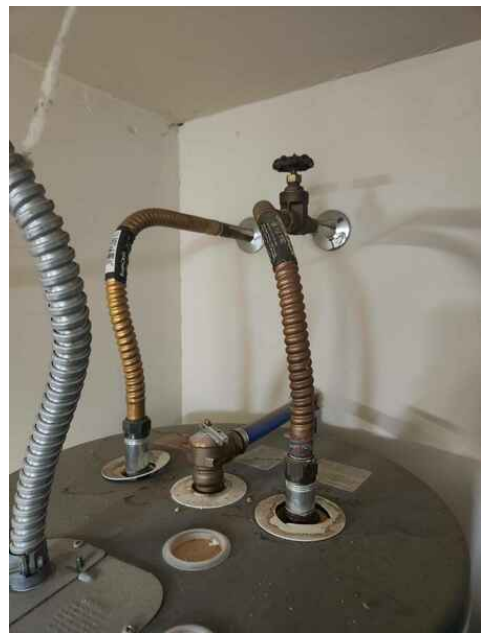
**NO BONDING AT WATER HEATER SUPPLY LINES**

Recommend a qualified electrician install bonding as required.

Contact a qualified electrical contractor.

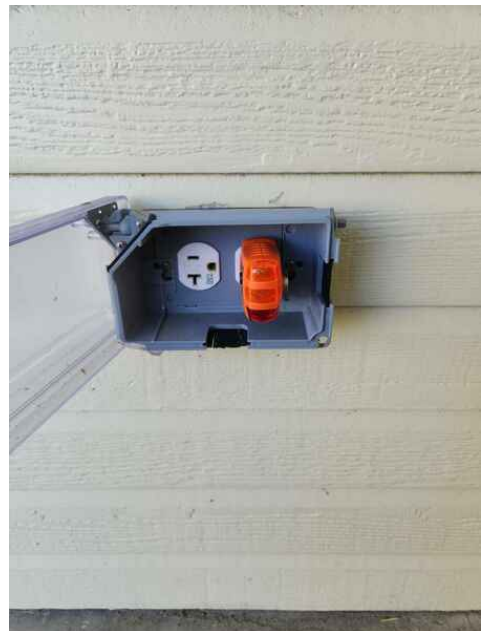
Back patio

**OUTSIDE RECEPTACLE INOPERABLE**

Both the front and back patio exterior receptacles did not show they were live when tested with outlet tester. Further Evaluation by a qualified electrician is recommended.

Contact a qualified electrical contractor.

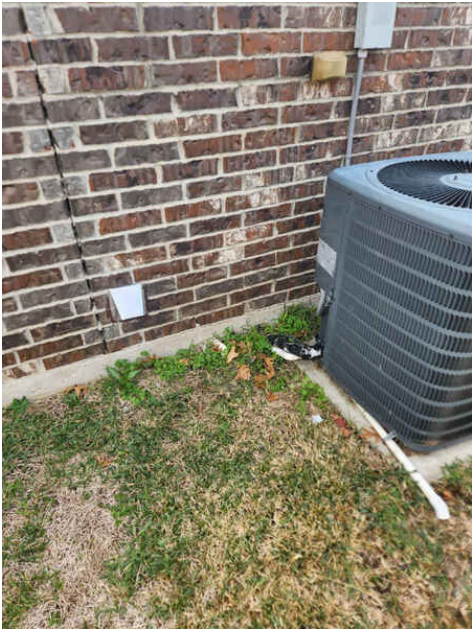
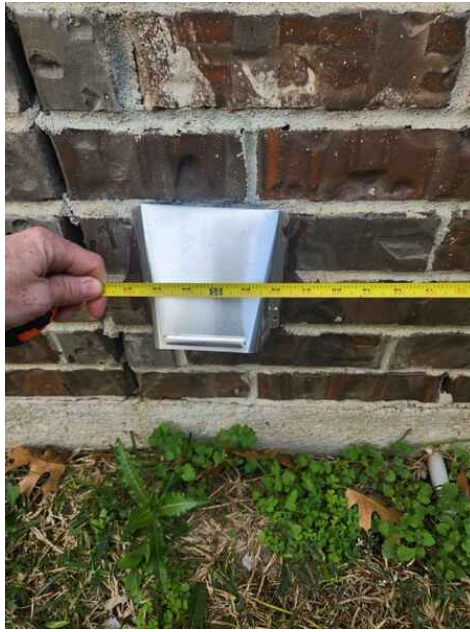
**DRYER EXHAUST TOO CLOSE TO CONDENSER UNITS**

Dryer exhaust vents should terminate at least 3 feet away from condenser units. The exhausted heat can make the condenser inefficient at expelling heat, exhaust lint that can clog the coils and decrease efficiency, and the exhaust can contain chemicals that may damage the condenser. Recommend repair by a qualified professional to have the exhaust as far away from the condenser unit while maintaining requirements for dryer vent.

Contact a qualified professional.

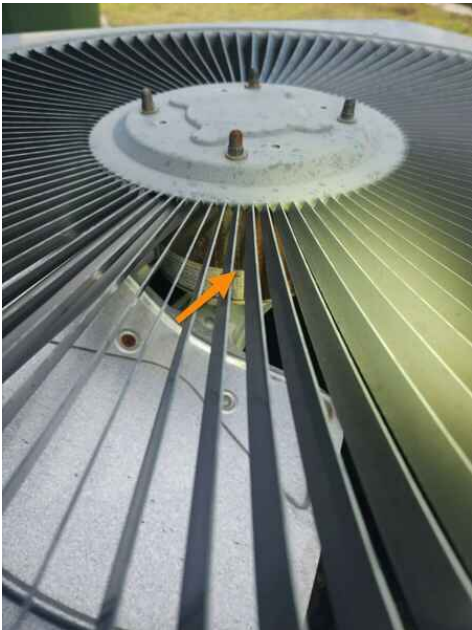
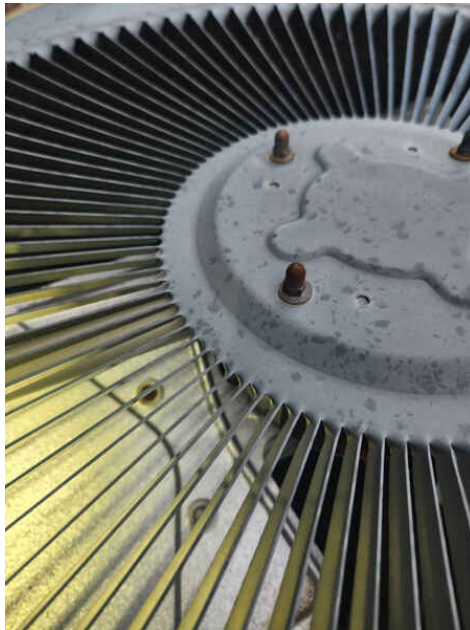
#### 4.2.3 B. Cooling Equipment **RUST AT CONDENSER UNIT**

This is likely due to age of the outdoor unit.

Recommendation  
Contact a qualified professional.

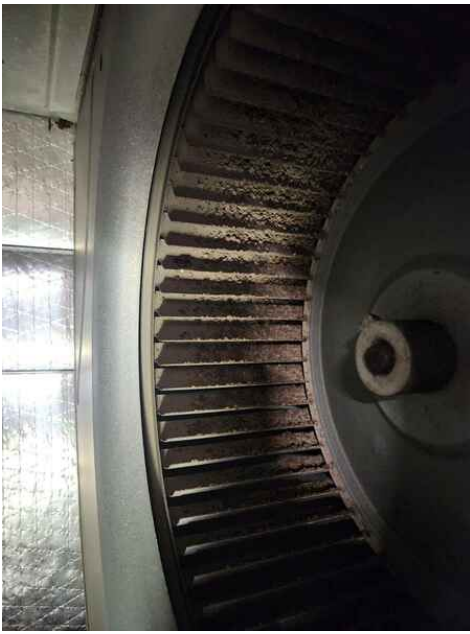
#### 4.2.4 B. Cooling Equipment **DIRTY BLOWER FAN**

Recommend a qualified HVAC professional clean the blower fan on the forced air unit.

Recommendation  
Contact a qualified HVAC professional.

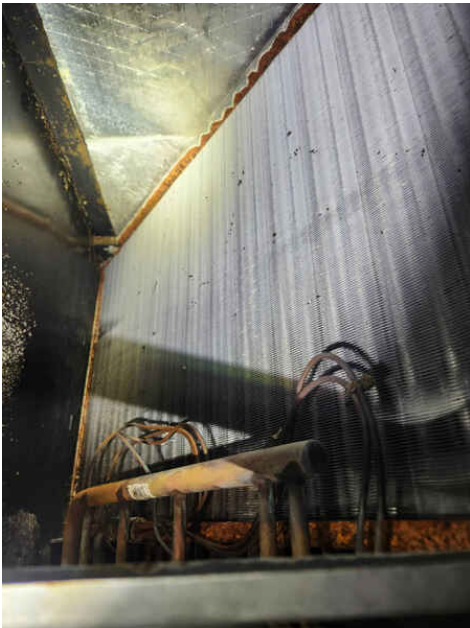
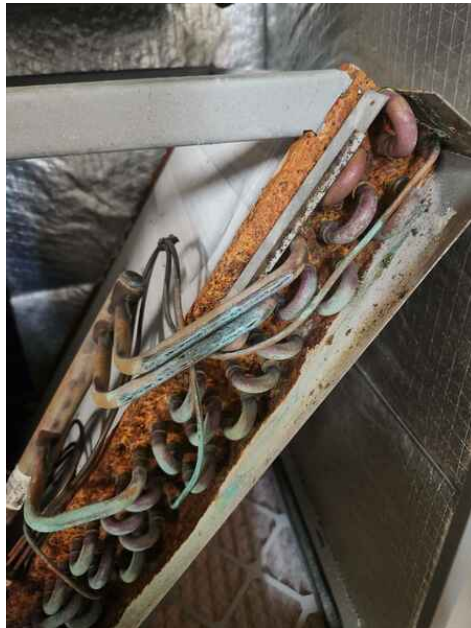
### RUST AND DIRT AT EVAPORATOR COIL

Rust may lead to leaks over time and result in evaporator coil needing replaced. Dirt was also observed on the coil. Recommend a qualified HVAC professional clean as required.

Contact a qualified HVAC professional.

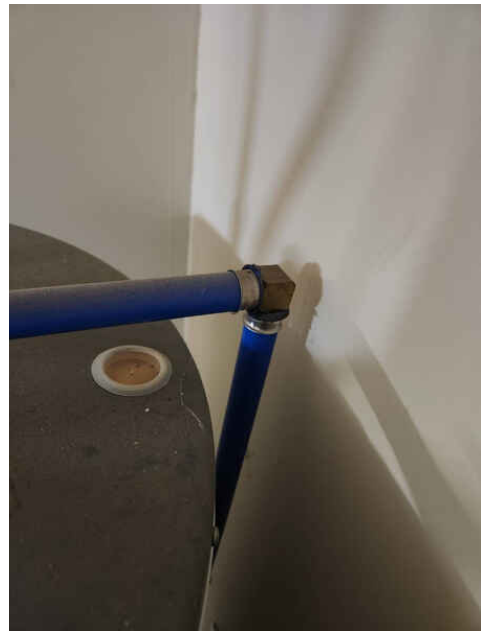
5.3.1 C. Water Heating Equipment  
**IMPROPER TPR VALVE EXTENSION MATERIAL**

The TPR valve extension material was observed to be a PEX type pipe which is not approved for this purpose. Recommend replacement with proper type of material.

Contact a handyman or DIY project

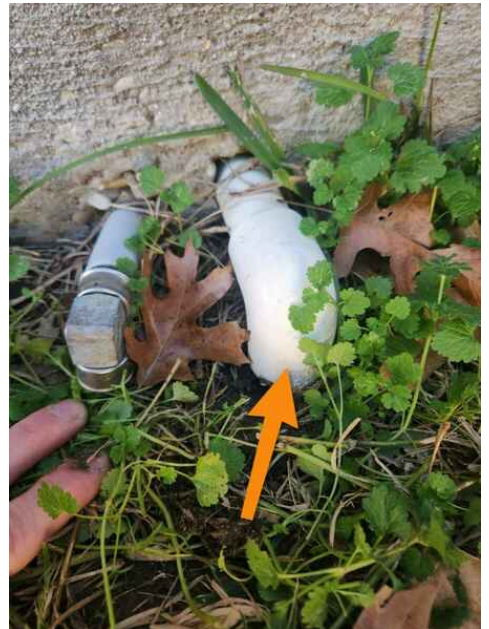
5.3.2 C. Water Heating Equipment  
**DRAIN TERMINATES TO CLOSE TO GRADE**

A drain termination (appears to be either water heater drain pan or condensate drain but could not be determined) was below the grade level. Recommend correction by a qualified professional so it can drain properly

Contact a qualified professional.
