RIVERBEND INSPECTIONS RESIDENTIAL INSPECTION COPY

1234 Main Street
Waco TX 76708

01/16/2024 9:00AM

PROPERTY INSPECTION REPORT FORM

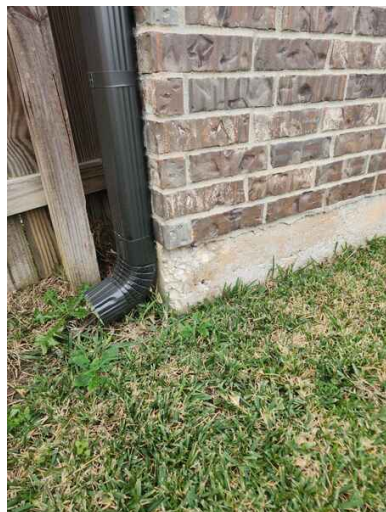
Observed at back right corner. Corner pops can be cause by multiple factors including damage, thermal expansion of masonry veneers, and more. They are common at foundation corners and are cosmetic in nature. Recommend repair as needed by a qualified professional.

Recommendation: Contact a qualified professional.

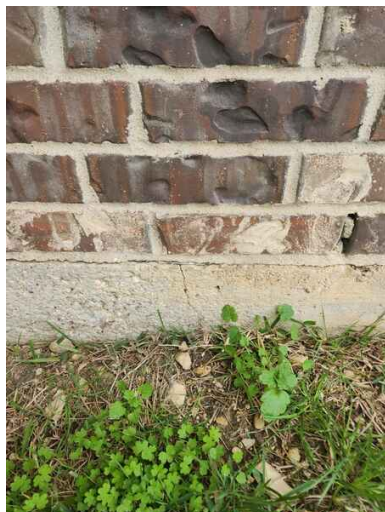
Back beside patio

2: Foundation Cracks - Minor

Minor cracking was noted at the foundation. This is common as concrete ages and shrinkage surface cracks are normal. It not appear to be more than 1/4" wide or show signs of vertical displacement, or being wider at the top or bottom. Recommend monitoring for more serious shifting/displacement. If you have any further concerns about these cracks we recommend having a foundation specialist provide further evaluation and repair as recommended.

Recommendation: Recommend monitoring.

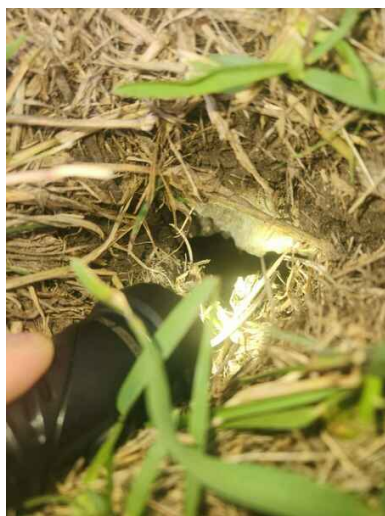
3: Potential Animal borrow

There was a hole in the ground near the front left corner downspout that may be a potential animal burrow but further evaluation would be needed by a pest control specialist to confirm. The hole is beside the foundation and goes below the footing. This hole may collect water and impact the integrity of the soil at the foundation which could lead to foundation issues if not corrected. Recommend a pest control specialist evaluate further and infill the hole after any pest concerns have been take care of.

Recommendation: Contact a qualified professional.

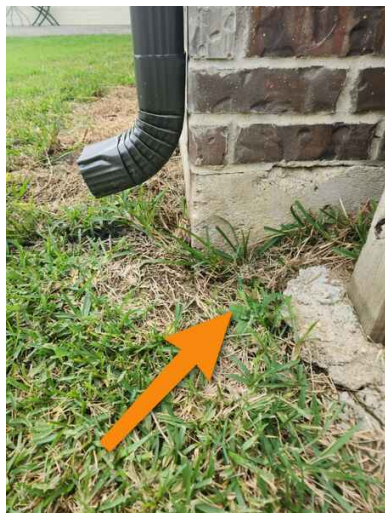
Left Side at Back

Low soil levels were observed at multiple locations at the foundation perimeter beam. Fill dirt is needed against the foundation perimeter wall to help support the foundation properly and to prevent ponding and erosion. Correction of low soil levels at the foundation is recommended.

Recommendation: Contact a qualified landscaping contractor

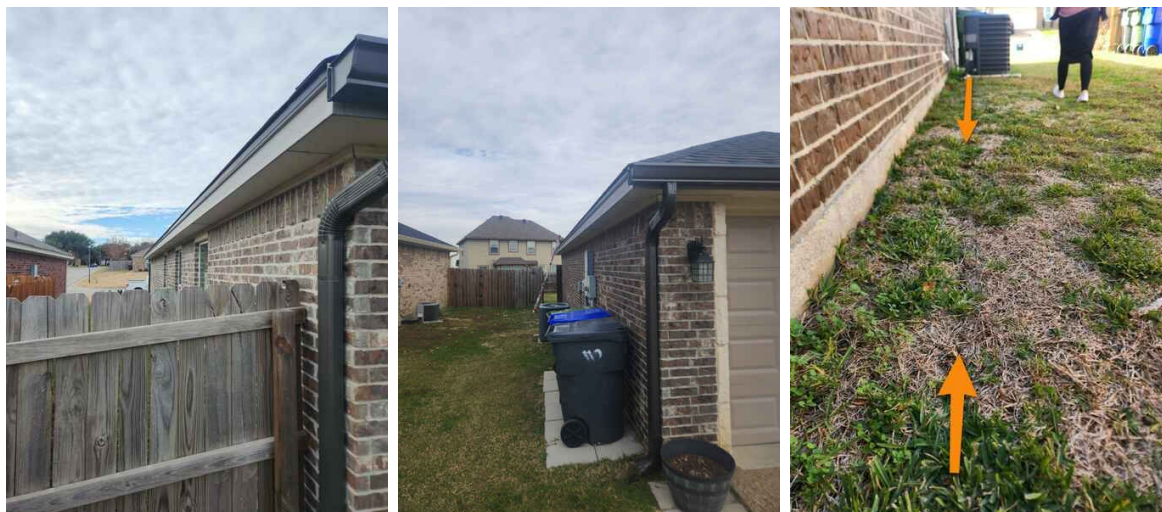
There was signs of erosion below the roofline where water is running off the roof where there is no guttering. In order for proper drainage away from foundation, and to prevent further erosion, installing guttering at the right and left sides is recommended.

Recommendation: Contact a qualified professional.

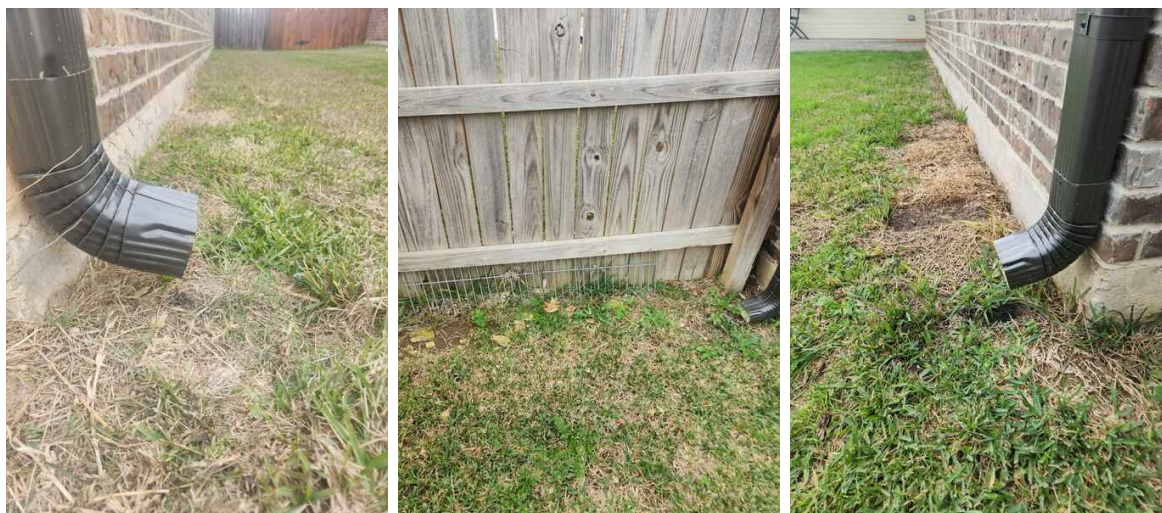
3: Termination too Close and Erosion at Downspouts

Erosion was observed at multiple downspouts. An extension or splash block is recommended to divert water at least 5 feet away from the foundation to prevent erosion and expanding of soil that may have an adverse impact on foundation performance.

Recommendation: Contact a handyman or DIY project

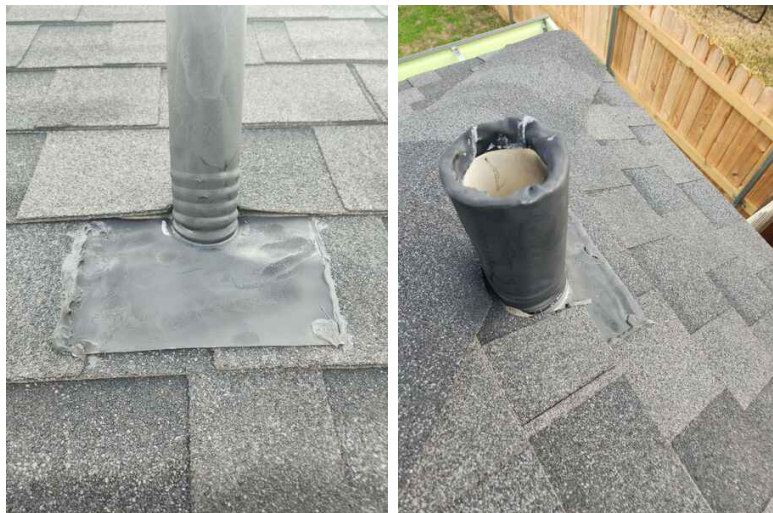
There was roofing sealant used to seal edges of vent boots at multiple locations. May be a potential repair to a leaking flashing. Recommend inquiring of the current owner about any leaks or repairs that may have been made. Sealants at flashings are not a permanent solution. Repair and replacement by a qualified roofing contractor is recommended if this was an attempted repair.

Recommendation: Contact a qualified roofing professional.

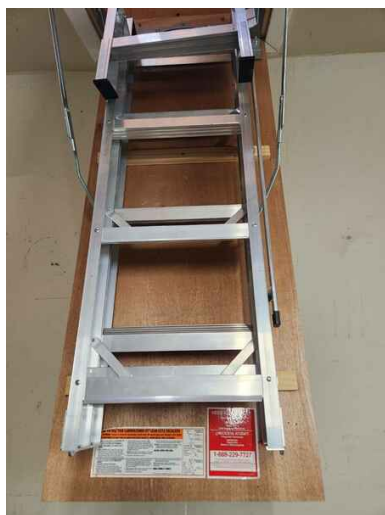
The attic stair door was not fire rated and breaks the continuity of fire separation between the home and attached garage which is required by current standards.

Recommendation: Contact a qualified carpenter.

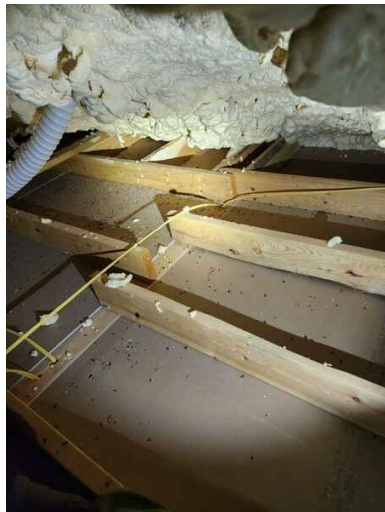
2: Evidence of Rodents

There was a significant amount of rodent droppings in the attic. Recommend a pest control specialist provide further evaluation and make necessary corrections to prevent further damage (see note regarding damage in walls section).

Recommendation: Contact a qualified professional.

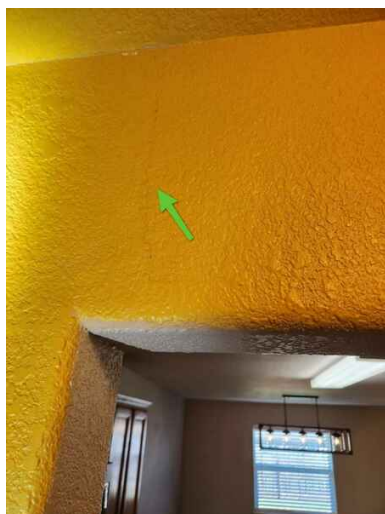
Laundry Room

There were a couple of interior locations where repairs appear to have been made. If these areas are of concern inquiring about the repairs from the current owner is recommended.

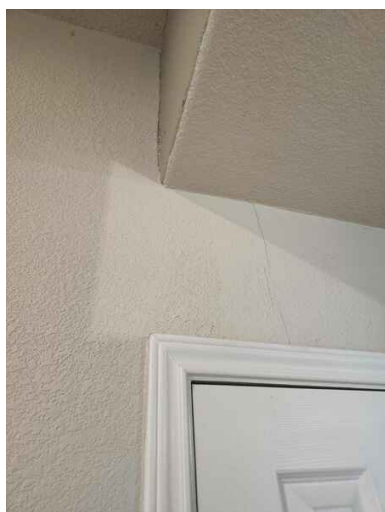
Pantry Door

1: Cracks - Seam (cosmetic):

Seems cracks are common over time and due to minor settlement and are cosmetic in nature. There were seem cracks observed at the following locations:

Recommendation: Contact a qualified professional.

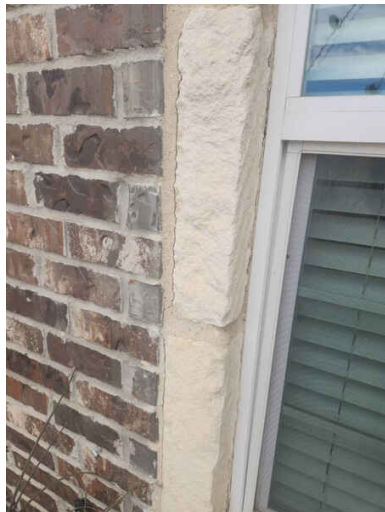
Front Window by Front Door

2: Cracking- Mortar minor

There were multiple locations observed that had minor mortar crack. The cracks appear to shrinkage cracks and are mostly cosmetic in nature. Mortar Cracks can allow moisture intrusion and cause further deterioration of masonry cladding.

Recommendation: Contact a qualified professional.

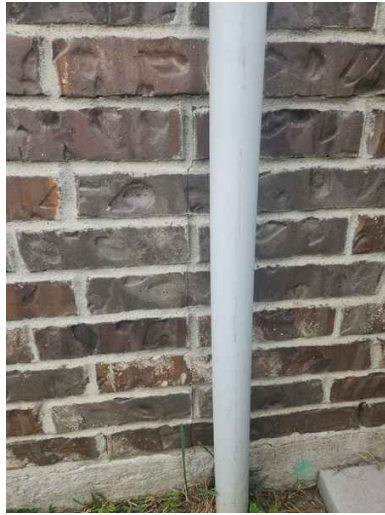
3: Crack In Masonry

A crack was observed at the exterior cladding that goes through both the mortar and masonry. Recommend repair of crack and monitoring for additional movement and/or expansion.

Recommendation: Recommend monitoring.

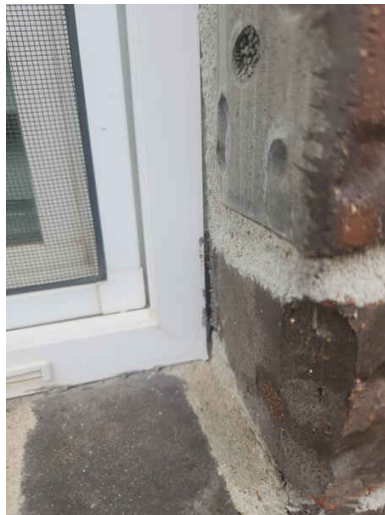
4: Window Sealant Not Adequate

There was one or locations where the sealant between the window and the cladding could use minor improvement. It is recommended that sealant be properly installed to seal this gap to prevent water, pest, and insect intrusion.

Recommendation: Contact a handyman or DIY project

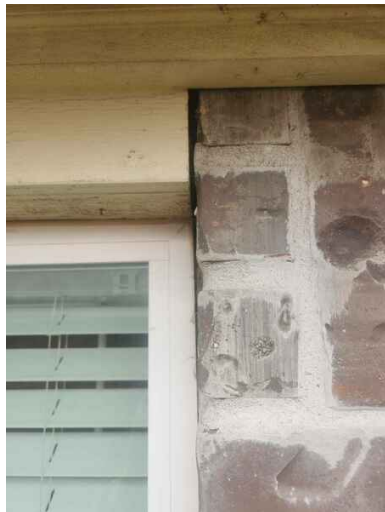
Multiple Windows

5: Sealant Improvements at Exterior Trim

Sealant was observed to be missing, deteriorated, or inadequate and in need of improvement at exterior trim at one or more locations. Recommend improvement be made to prevent moisture, pest, and insect intrusion.

Recommendation: Contact a handyman or DIY project

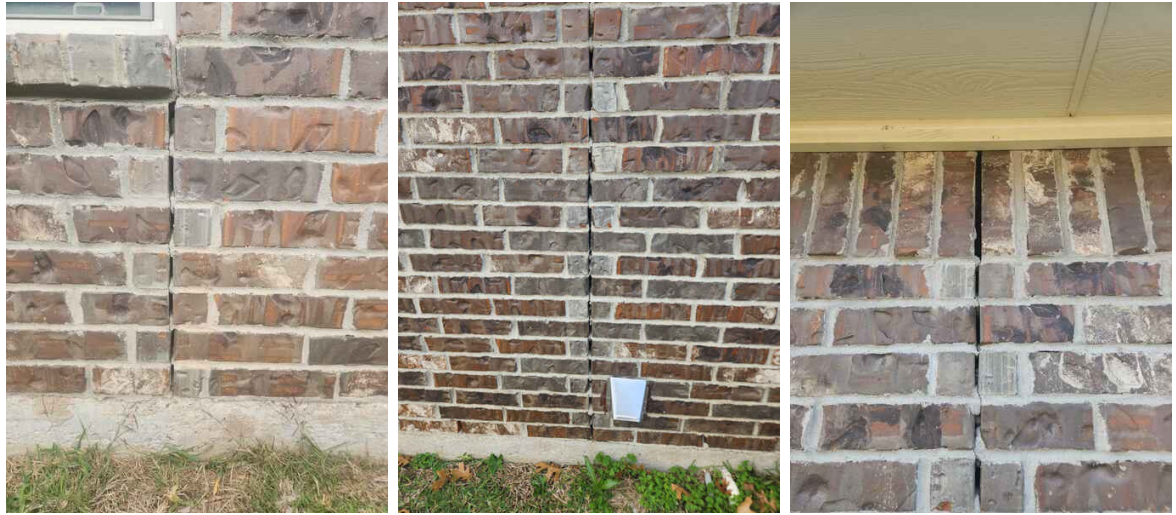
There was no sealant observed in the brick control joints. It is recommended that sealant be properly installed to seal this gap to prevent water, pest, and insect intrusion.

Recommendation: Contact a handyman or DIY project

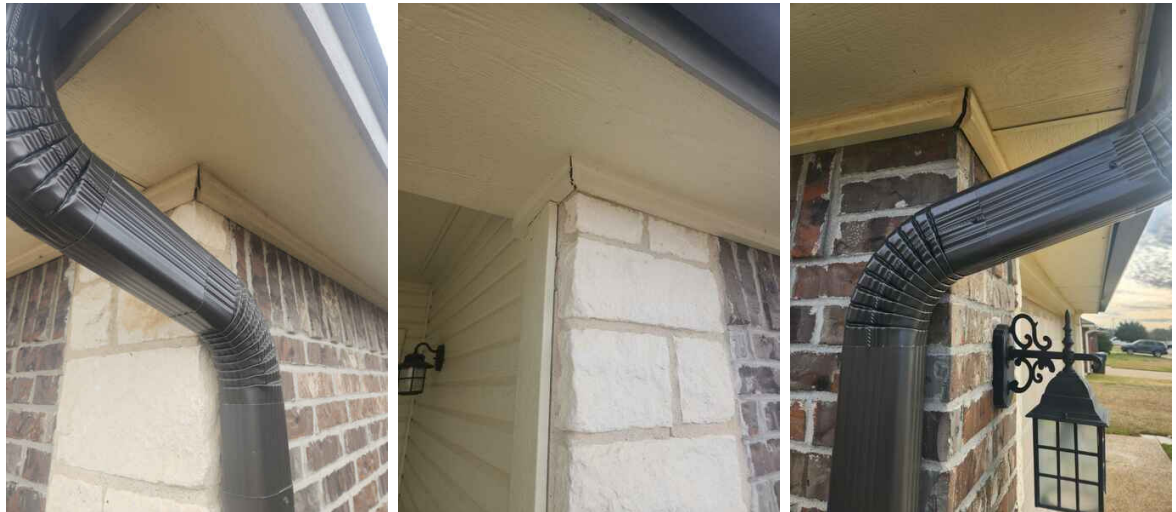
8: Frieze Board Gap

The frieze board trim has separated at several corners. It is recommended that sealant be properly installed to seal this gap to prevent water, pest, and insect intrusion.

Recommendation: Contact a handyman or DIY project

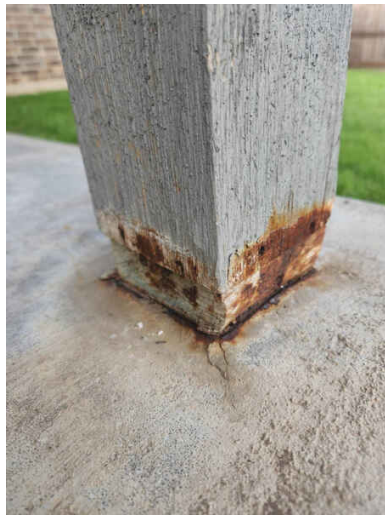
9: Wood Column Deterioration

There is some signs of deterioration at the bottom of the wood column at the back patio. Recommend a qualified contractor or handyman install a metal bracket or other form of separation between the concrete and wood column.

Recommendation: Contact a qualified professional.

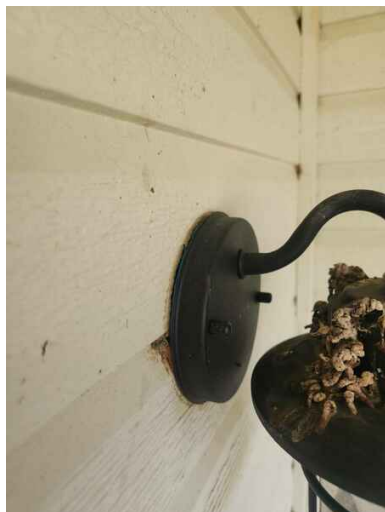
10: Sealant at back patio fixture

It is recommended that sealant be properly installed to seal this gap to prevent water, pest, and insect intrusion.

Recommendation: Contact a qualified professional.

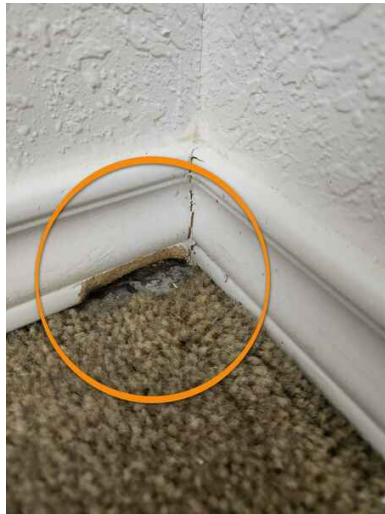
Master closet

13: Potential Rodent Damage

What appeared to be rodent damage and access point was observed in the corner of the master bedroom walk-in closet. Recommend a pest control specialist evaluate further and make corrections as require.

Recommendation: Contact a qualified professional.

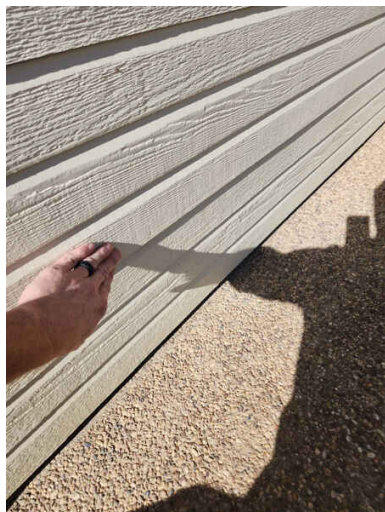
Right of garage at entry

14: Loose siding

There was a section of siding that was loose and bowed out from wall slightly at the front entry. Recommend a qualified carpenter make the necessary repairs.

Recommendation: Contact a qualified professional.

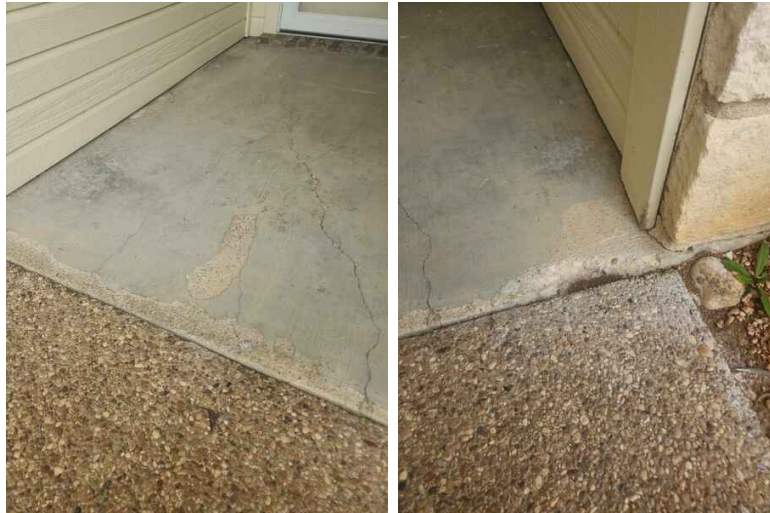
2: Damage to concrete at patio

Recommendation: Contact a qualified concrete contractor.

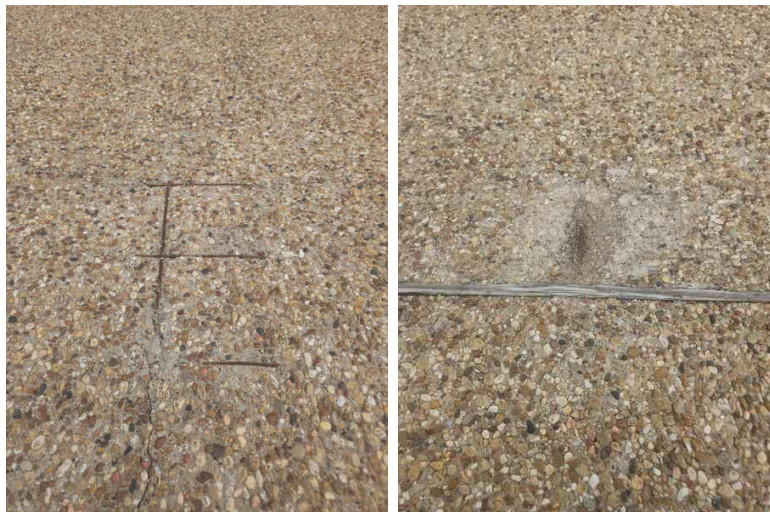
3: Exposed Reinforcing

Recommend repair by a qualified contractor to prevent further deterioration.

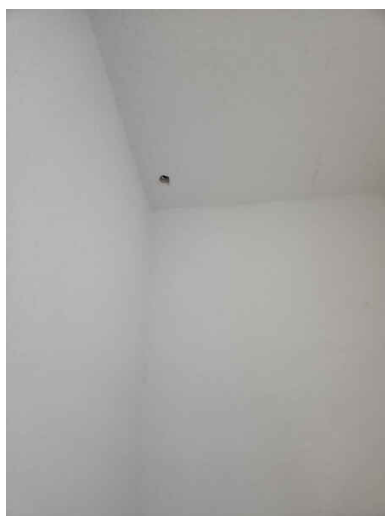
Closet of first bedroom on right

There was an abandoned hole in the closet ceiling. Recommend repairing hold as required.

Recommendation: Contact a handyman or DIY project

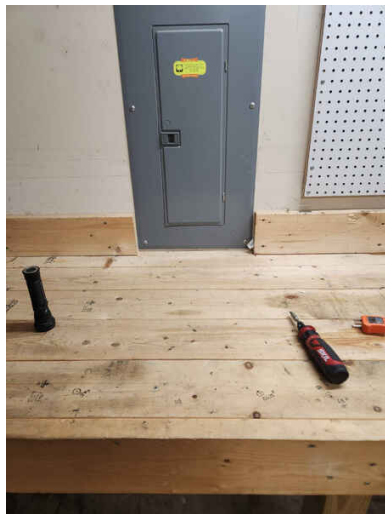
2: Improper Clearance

There should be 3 feet in front of the panel and 30 inches side to side for clearance for anyone to safely work at the panel if needed. Recommend making corrections as needed for the proper clearance.

Recommendation: Contact a qualified professional.

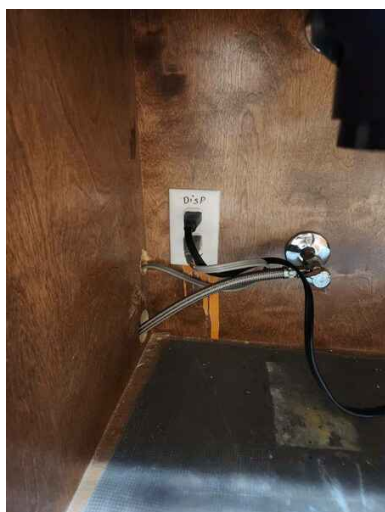
Dishwasher Plug in Under Sink

1: Absence of Ground Fault Circuit Interrupter (GFCI) Protection

GFCI protection (Breaker or receptacle) are required in the following locations per current building standards; bathroom receptacles, garage and accessory building receptacles, outdoor receptacles, crawl space receptacles and lighting outlets, basement receptacles, receptacles that serve kitchen countertops, receptacles that are located within six feet of the outside edge of a sink, shower, or bathtub, laundry area receptacles, indoor damp and wet location receptacles, kitchen dishwasher receptacle, and electrically heated floors. Recommend a qualified electrician make the necessary repairs to provide GFCI protection for locations noted.

Recommendation: Contact a qualified electrical contractor.

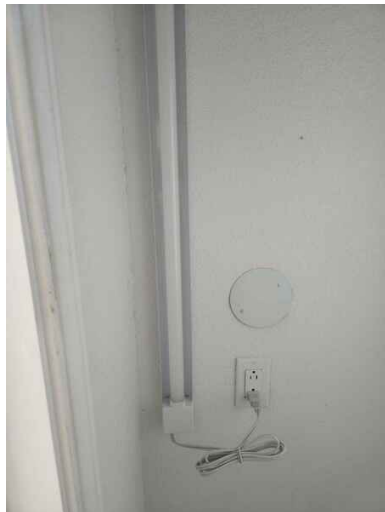
Front Bedroom Closet

Extension cord(s) used as permanent electrical conductors was observed. Electrical standards do not allow extension cords to be used for permanent wiring and is considered a safety hazard. Recommend replacement of extension cord wiring with the appropriate electrical conductors by a qualified electrician.

Recommendation: Contact a qualified electrical contractor.

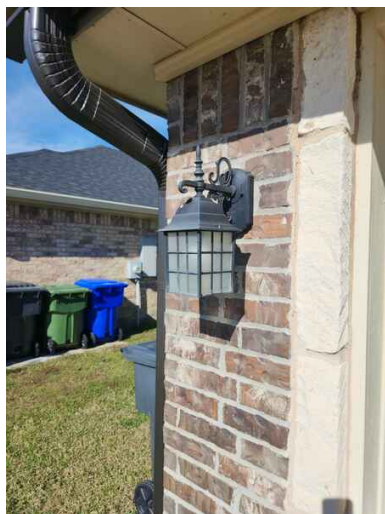
5: Inoperable Fixture

Fixture did not turn on when the switch was operated. This may be the result of a burned out light bulb , but may be a defective fixture. Recommend further evaluation and repair as necessary.

Recommendation: Contact a handyman or DIY project

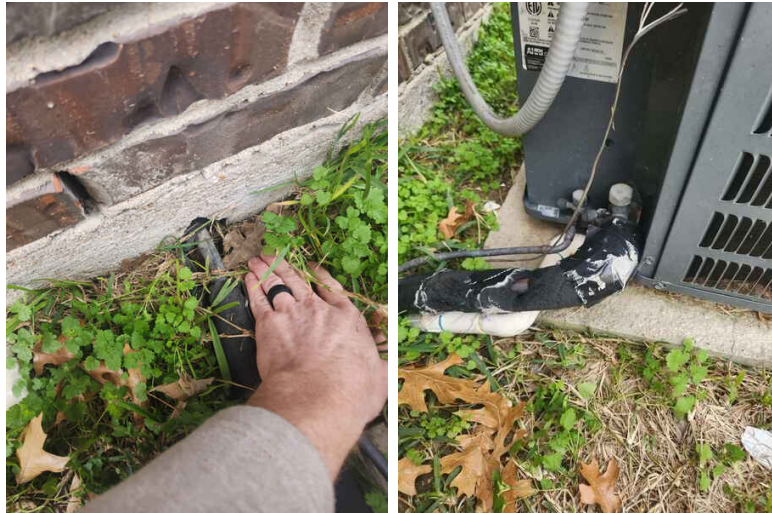
3: Rust at Condenser Unit

This is likely due to age of the outdoor unit.

Recommendation: Contact a qualified professional.

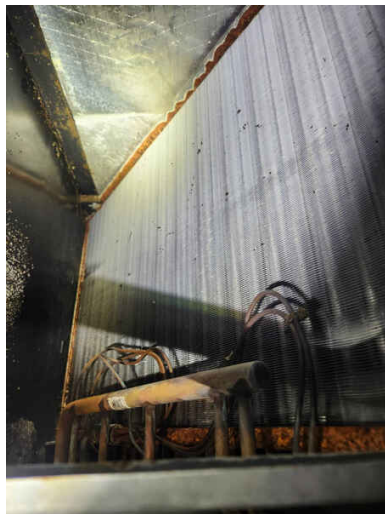
5: Rust and Dirt at Evaporator Coil

Recommendation: Contact a qualified HVAC professional.

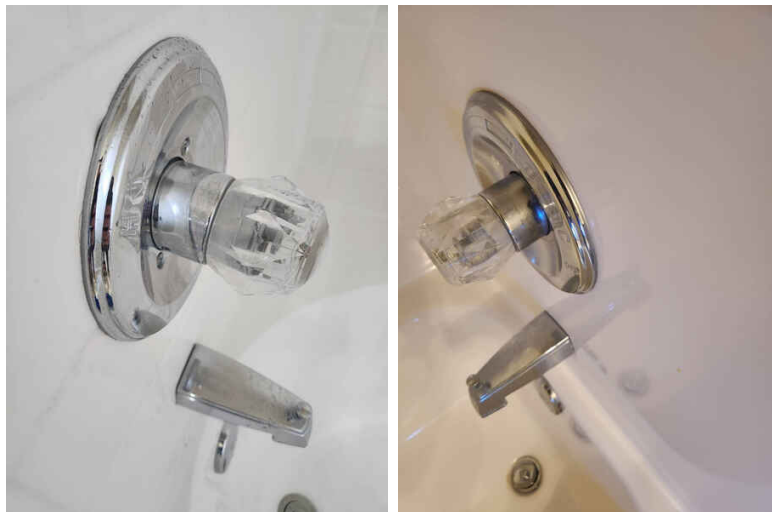
Hall Bath

2: Lack of Sealing Around Shower Fixtures

Recommendation: Contact a handyman or DIY project

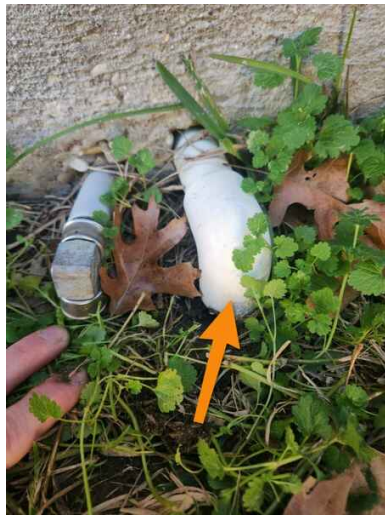
2: Drain Terminates to Close to Grade

Recommendation: Contact a qualified professional.
