## SUMMARY

1234 Main Street Waco TX 76708

Kris Cline  
TREC #26170  
Riverbend Inspections PLLC  
254-253-9051  
[kris@riverbendinspections.com](mailto:kris@riverbendinspections.com)

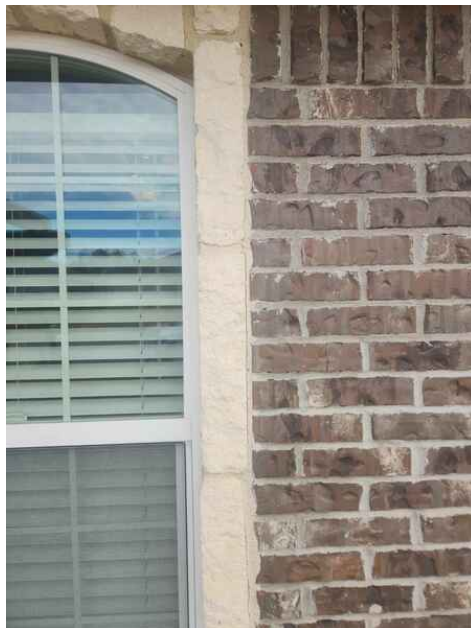
Front Right Window

**CRACKING- MORTAR MINOR**

There were multiple locations observed that had minor mortar crack. The cracks appear to shrinkage cracks and are mostly cosmetic in nature. Mortar Cracks can allow moisture intrusion and cause further deterioration of masonry cladding.

Recommendation  
Contact a qualified professional.
