RIVERBEND INSPECTIONS RESIDENTIAL INSPECTION COPY

1234 Main Street
Waco TX 76708

01/16/2024 9:00AM

PROPERTY INSPECTION REPORT FORM

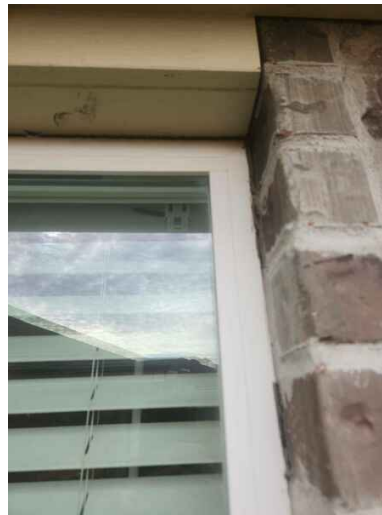
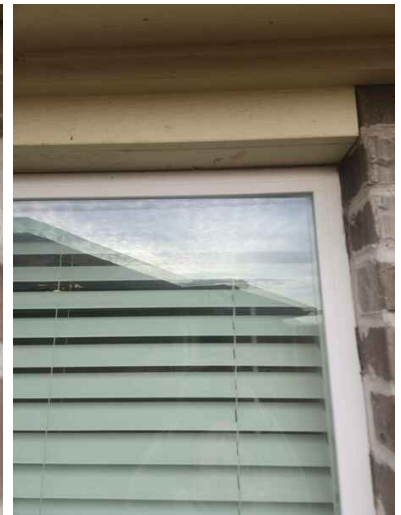
There was one or locations where the sealant between the window and the cladding could use minor improvement. It is recommended that sealant be properly installed to seal this gap to prevent water, pest, and insect intrusion.

Recommendation: Contact a handyman or DIY project

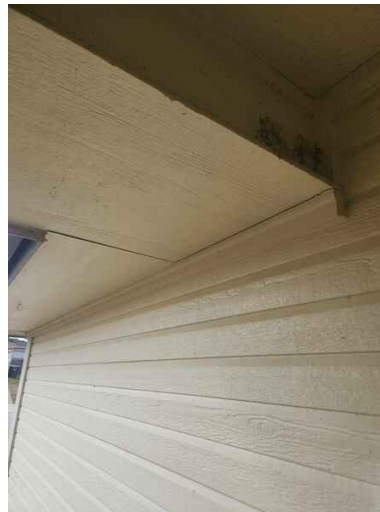
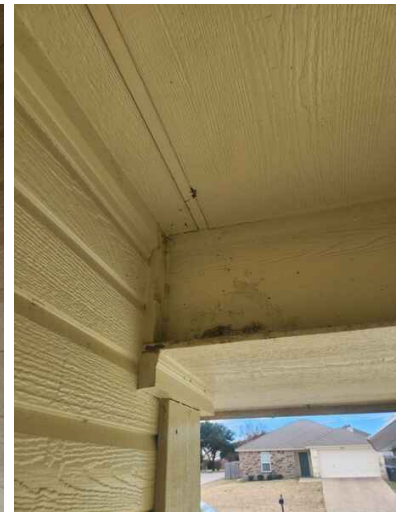
Multiple Windows

Sealant was observed to be missing, deteriorated, or inadequate and in need of improvement at exterior trim at one or more locations. Recommend improvement be made to prevent moisture, pest, and insect intrusion.

Recommendation: Contact a handyman or DIY project

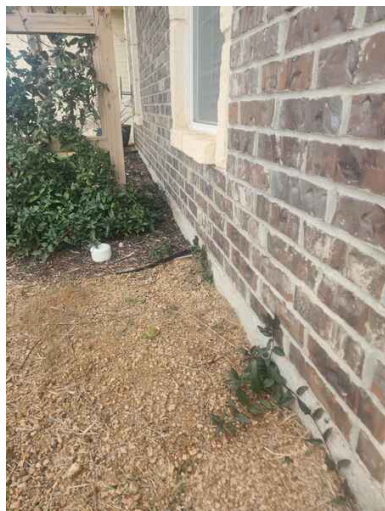
Vegetation was observed starting to grow to close to the exterior wall at the front of the house. Vegetation to close to the home can lead to water, pest, and insect intrusion and interfere with ability to perform maintenance work around the home. Recommend vegetation be trimmed to be at least one foot away from wall.

Recommendation: Recommended DIY Project

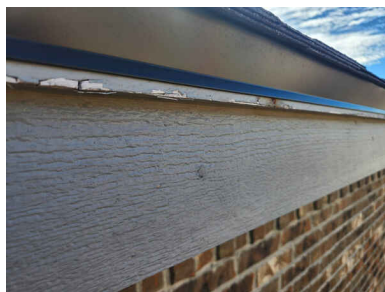
Left side eve

Paint is chipping and or peeling at eve below drip edge at left side of house. Recommend painting improvement be made as needed to protect the trim and prevent moisture damage.

Recommendation: Contact a qualified professional.

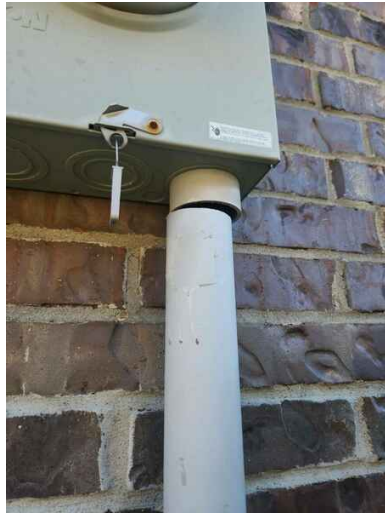
2: Improper Clearance

There should be 3 feet in front of the panel and 30 inches side to side for clearance for anyone to safely work at the panel if needed. Recommend making corrections as needed for the proper clearance.

Recommendation: Contact a qualified professional.

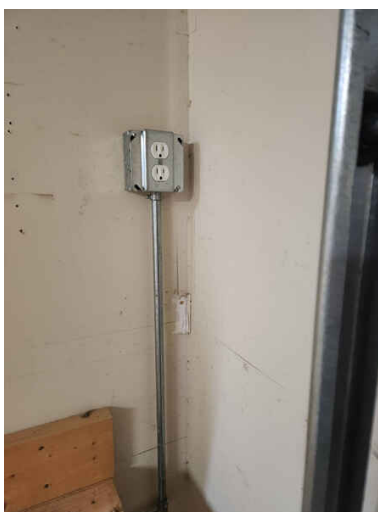
Garage

GFCI protection (Breaker or receptacle) are required in the following locations per current building standards; bathroom receptacles, garage and accessory building receptacles, outdoor receptacles, crawl space receptacles and lighting outlets, basement receptacles, receptacles that serve kitchen countertops, receptacles that are located within six feet of the outside edge of a sink, shower, or bathtub, laundry area receptacles, indoor damp and wet location receptacles, kitchen dishwasher receptacle, and electrically heated floors. Recommend a qualified electrician make the necessary repairs to provide GFCI protection for locations noted.

Recommendation: Contact a qualified electrical contractor.

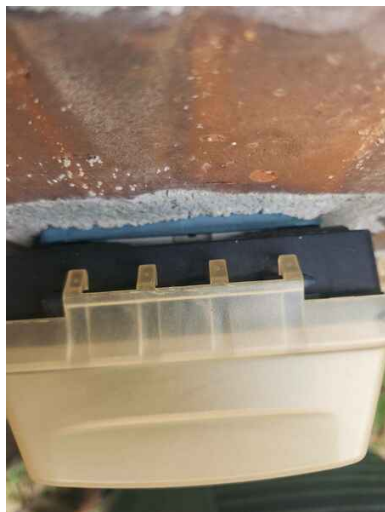
Left side exterior

Electrical outlet and receptacle were exposed at left side exterior receptacle. This could lead to moister entering the outlet and poses a safety risk. Recommend the necessary repairs be made by a qualified professional to protect electrical outlet and receptacle from water exposure.

Recommendation: Contact a qualified professional.

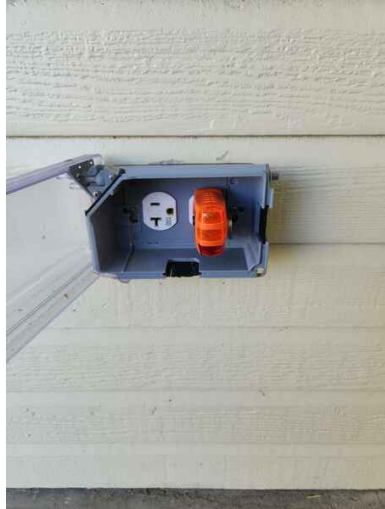
Back patio

Both the front and back patio exterior receptacles did not show they they were live when tested with outlet tester. Further Evaluation by a qualified electrician is recommended.

Recommendation: Contact a qualified electrical contractor.

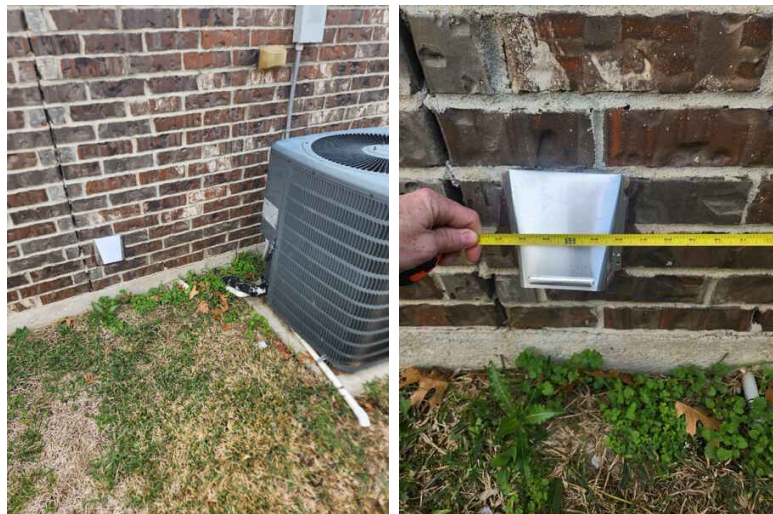
Dryer exhaust vents should terminate at least 3 feet away from condenser units. The exhausted heat can make the condenser inefficient at expelling heat, exhaust lint that can clog the coils and decrease efficiency, and the exhaust can contain chemicals that may damage the condenser. Recommend repair by a qualified professional to have the exhaust as far away from the condenser unit while maintaining requirements for dryer vent.

Recommendation: Contact a qualified professional.

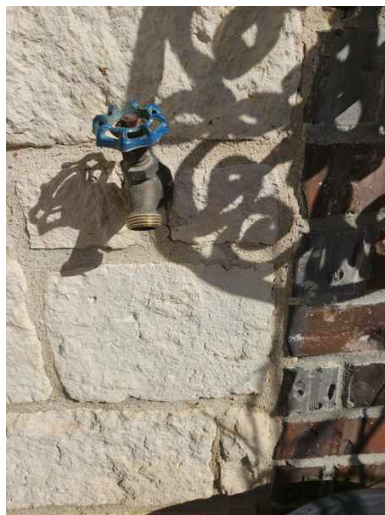
4: High water pressure

Static Water Pressure Reading:: 80 to 85
